RivGen Open Water Deployment Report

<b>2019 RivGen Open Water Deployment Report</b>	<b>Document Number</b>	<b>RS-RV20-10731</b>
		<b>Award Number</b>	<b>DE-EE0007348</b>
		<b>Project</b>	<b>IVC DOE RivGen</b>

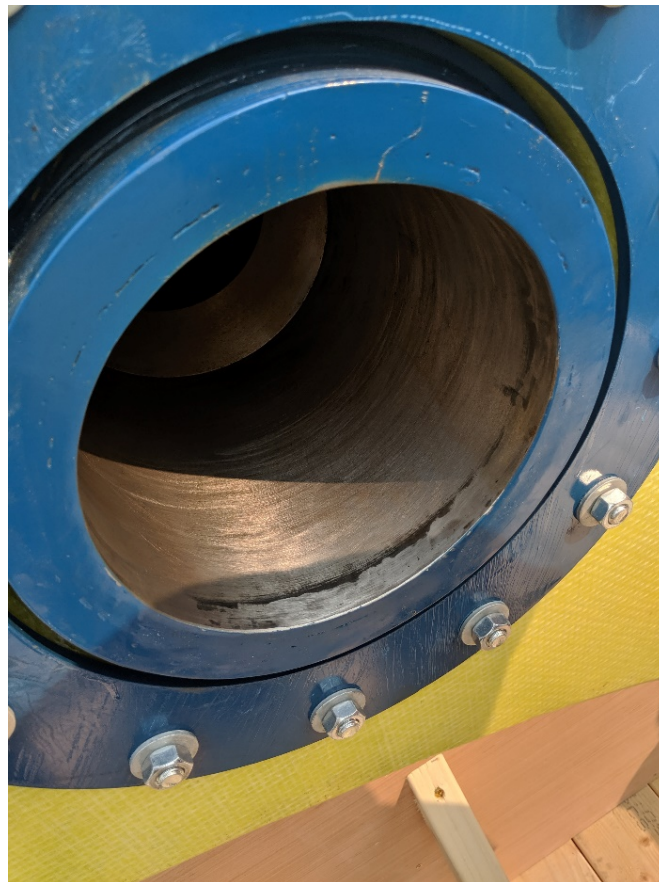
The turbines arrived in Igiugig on July 6. Prior to installing the turbines, they were visually inspected, and fit tests between the turbine shaft and ETP couplings which connects the turbines to the driveline were conducted. Unfortunately, these tests revealed that the turbine shafts were not able to fit on the ETP coupling. After careful inspection and measurements with an inside hole micrometer, it was confirmed that the turbine shaft inner dimensions did not meet the specified tolerances (Figure 9). It appeared that this may have been a result of machining the shaft inserts prior to welding, which lead to shaft deformation. It was for this reason that the fabrication drawings specified machining to be done *after* welding.

Figure 9. Example of a turbine shaft ID as received. Measurements and visual inspection indicated shaft ID did not meet fabrication specifications.

Over the course of the next week, a number of different techniques were used to correct the shaft ID. Ultimately, a cylinder hone was used to slowly remove small amounts of material from the inside of the shaft and bring the shaft into tolerance (Figure 10). This process took several days.

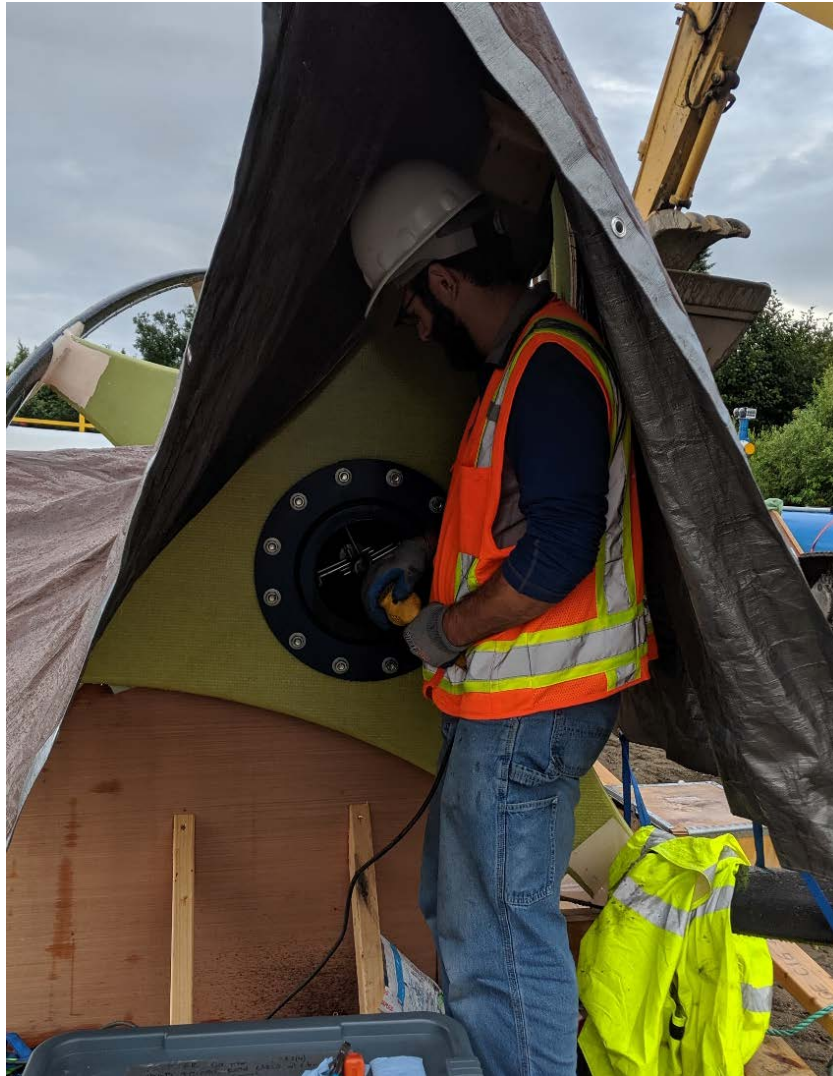
Figure 10. To correct tolerance issues on the turbine shaft ID a cylinder hone was used.

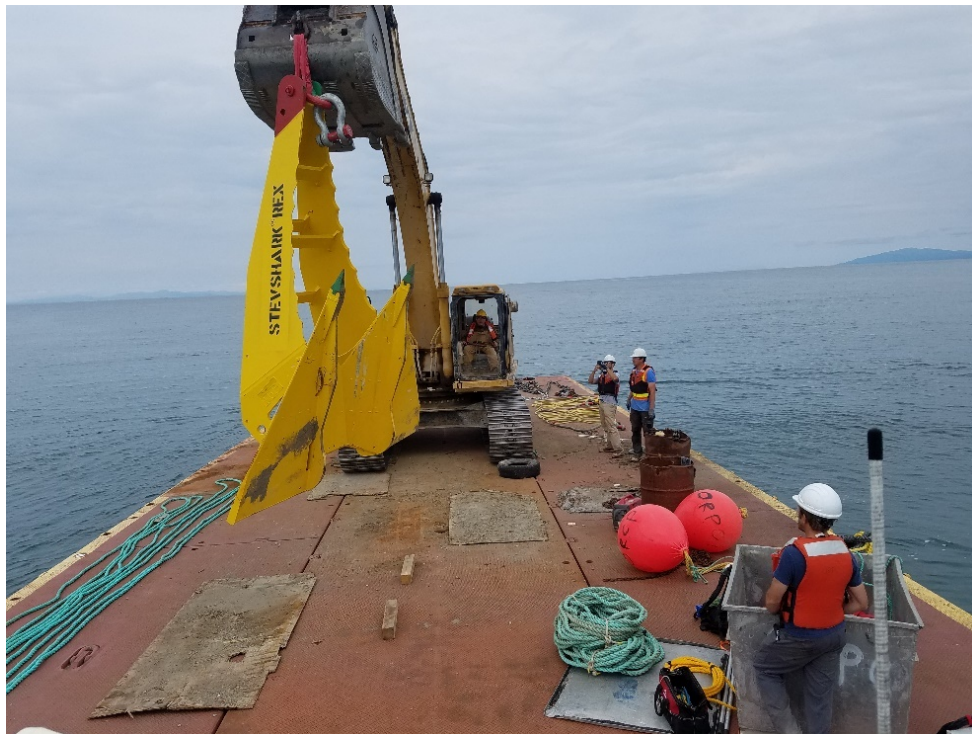
water. Due to the reach of the excavator, depth of the water, and length of the anchor, the excavator could not fully deploy the anchor in a single lift, and so a second chain hook was fixed to the barge such that “bights” could be taken to lower the anchor into the water. On July 12, this technique was tested in Lake Iliamna. It quickly became apparent that while the process of attaching and removing chain hooks was possible in the lake, in the river it might be dangerous for personnel and would likely result in anchor “fluttering,” which could cause damage to equipment or personnel. As a result, an alternative picking method using the excavator bucket to lift the chain was also tested. This also proved ineffective and unsafe, and led to a near-miss when the equipment operator accidentally released the chain and anchor onto the deck of the barge. This initial testing proved that a new technique would need to be devised and that lifting the anchor from the chain in a “vertical lift” was likely not possible given the limitations of the excavator and the depth of the river. In addition, lifting from the anchor chain created challenges with chain management. Lifting from the chain meant that two lengths of chain were elevated, one to the anchor and a second to the barge deck. Due to the size and weight of the chain to the deck, it was clear that controlling the deployment of the chain could become an issue.

Figure 17. Preliminary anchor lifting/deployment test

Based on the lake trials, it was determined that lifting from the chain was not advisable and lifting the anchor such that it was suspended horizontally was preferred to a vertical lift. Based on these lessons, a new technique for deploying the anchor was developed which utilized a separate lifting bridal comprised of wire rope (Figure 18). Due to high winds and waves on the lake, testing of this modified deployment technique was conducted in the Kvichak River near shore with the barge tethered to the shore. To further reduce risks, the initial lifting and deployment tests were conducted with the anchor chain removed from the anchor. A progression of tests was conducted with each test building on the previous test by

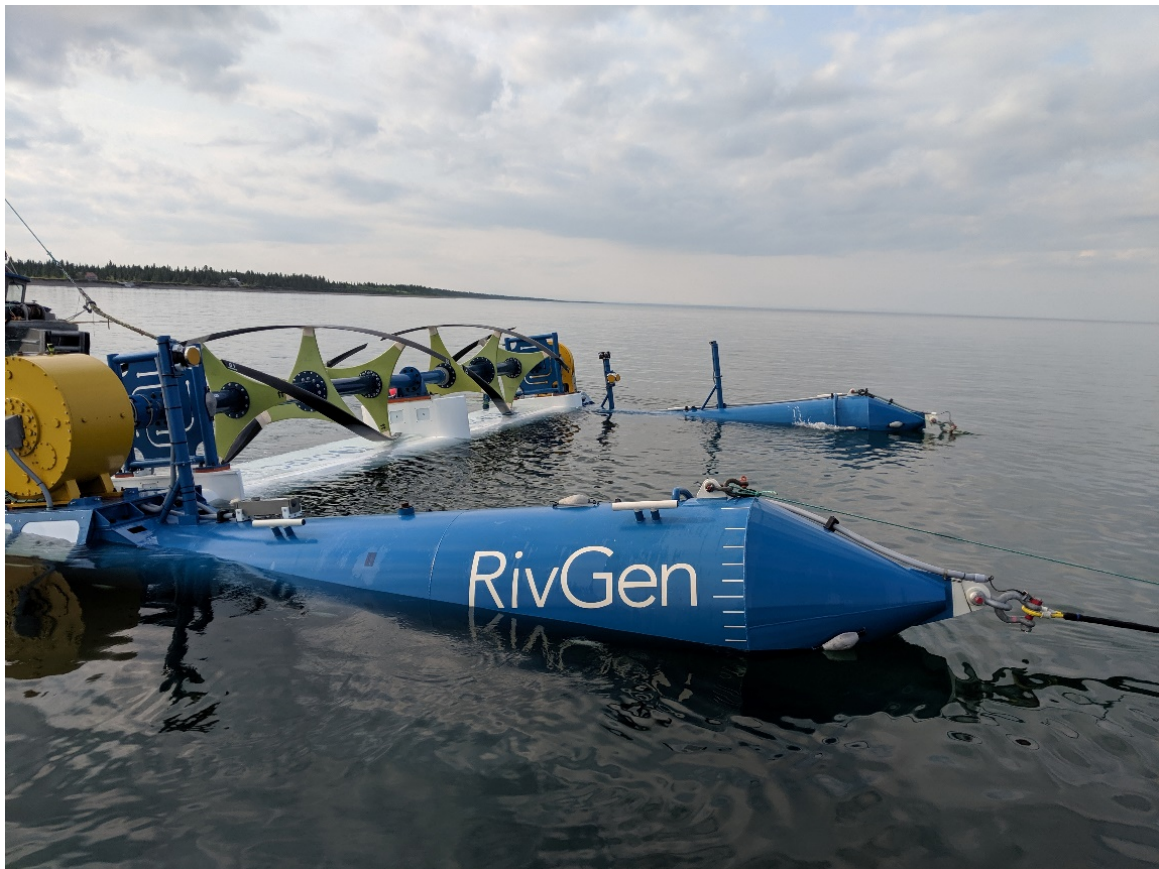
The final retrieval test used the secondary umbilical. The pop-up buoy (PUB) was released from the Chulyen and gathered by the work skiff. Although generally successful, the coiling of the secondary umbilical within the PUB resulted in some hose entanglement, which led to a modified coiling technique and the addition of light tensile “break-away” lines within the PUB to attempt to prevent the buoyancy of the hoses from out-pacing the buoyancy of the PUB upon release. With the secondary umbilical retrieved an “all chambers” evacuation was attempted. The test proved that this was not a viable option. Although stability did not appear to be an issue, the bow chambers rose to the surface first. This resulted in the water inside the chambers moving to the aft end of each chamber and away from the riser tube of the pontoon chambers, which prevented full evacuation and did not allow the device to fully surface. As a result, it was determined that the only viable retrieval techniques are SPL or an aft-first retrieval (Figure 23).

Figure 23. Retrieval attempt using secondary buoyancy system and "all chambers" evacuation, which resulted in "bow up" orientation that prevented full retrieval, highlighting the risk of an “all chambers” evacuation

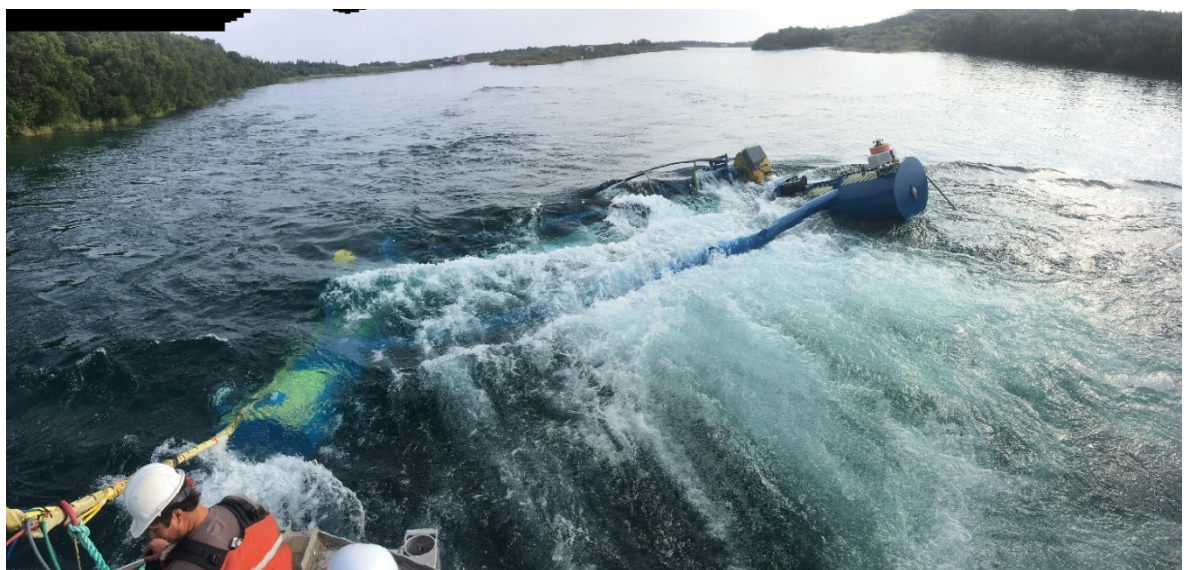
Figure 27. End pivot launch (bow down) deployment attempt

All of these were successful except for the bow-down deployment (Figure 27). In the deeper water of the river, with the bow down, the water in the partially filled aft pontoon chambers covered the air vacuum pipe prior to sufficient filling to sink the aft end. As a result, the bow was able to fully submerge; however, the aft end was not. This was due to the layout of the pontoon's internal plumbing. Once the cause of the issue was identified, the partially deployed device was retrieved without issue.

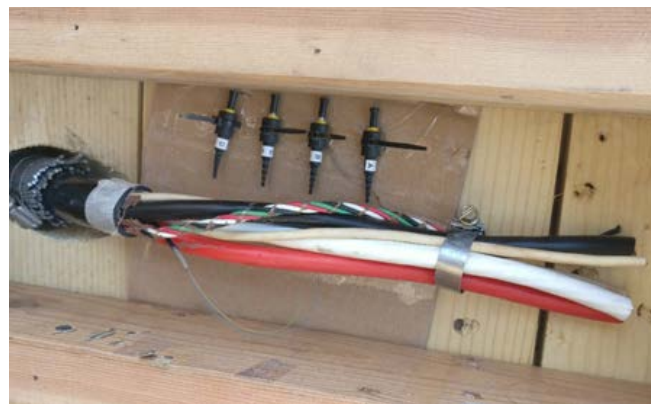
Although the submerged P&D cable had connectors on the RivGen device side of the cable the shore-side of the cable did not include connectors as the connections between the submarine and terrestrial cables would be made in the junction box by certified electricians. This meant that the fiber optic terminations were exposed to potential damage during handling (Figure 34). This was immediately identified as a concern and attempts were made to protect the exposed fibers. Unfortunately, these efforts were only partially successful as two of the fibers were damaged during cable installation. These damaged fibers were repaired by a fiber optic tech prior to completing initial commissioning.

Figure 34. Exposed Fibers (the four fiber terminations above the main cables with the exposed fibers extended below the main cable) at the submarine P&D cable shore-side termination
