CWPT Open Water Demonstration

DE-EE0008097

**Task 3.2 - Belt Tradeoffs for Winch PTO
Public Report**

May 2021

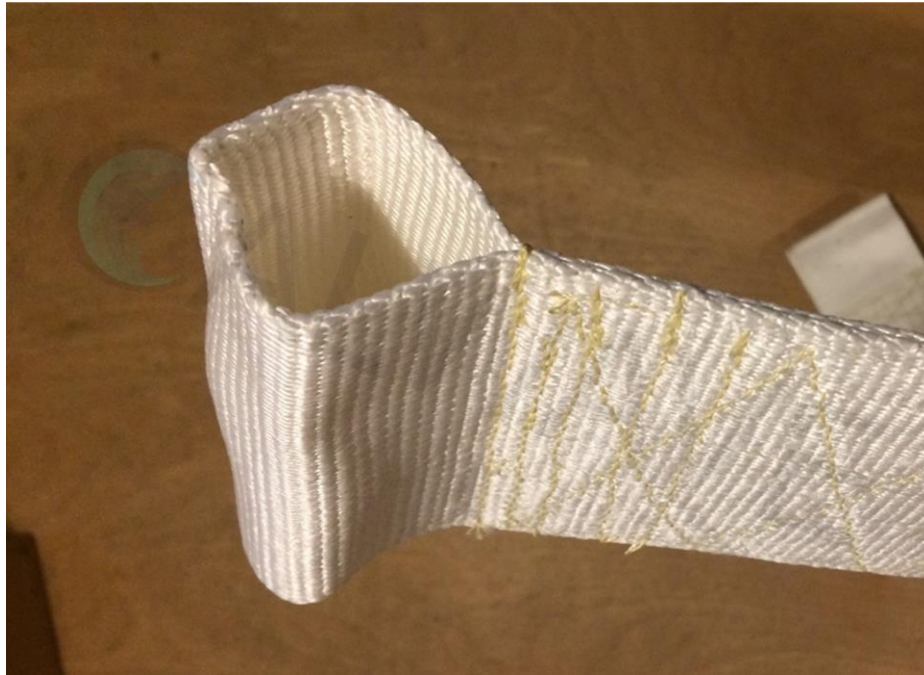
Figure 1: HMPE belt construction showing end loop termination.

CalWave collaborated with a textile manufacturer on the selection of an appropriate HMPE webbing belt. A sample of HMPE belt was supplied for testing on a CBOS testing setup at the Materials Testing Facility of the French Research Institute for Exploitation of the Sea (IFREMER). The scaled belt sample was nominally 6m long, 100 mm wide and 2.6 mm thick. The belt has a nominal breaking strength of 180 kN. End terminations were made by folding the belt end over and sewing the two sides together to create a loop, as shown in Figure 1.

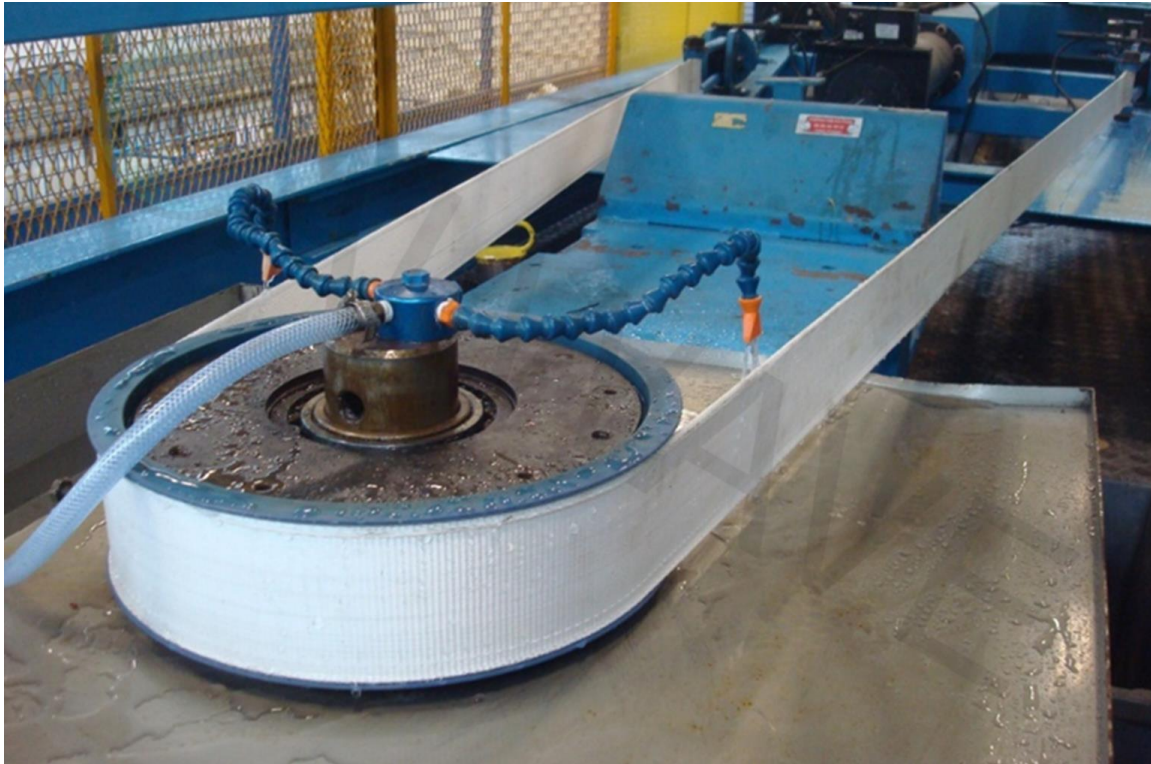
Figure 2: Experimental set up with sheave and belt mounted to the test machine.

Access to Ifremer's Material Testing Facility was provided through the MaRINET2 program. An HMPE belt sample as well as a new Nylon pulley sheave were supplied by CalWave to Ifremer. A single endurance testing experiment was planned for the full duration of facility access. A constant load of 90 kN was applied to the sheave, inducing a 45kN tensile load on the belt. The belt was displaced sinusoidally with an amplitude of 320 mm at a period of 14s in order to have sections of the belt fully pass on and off the sheave during each cycle. Note that this leads to two bend-unbends per cycle, whereas a belt wrapping on and off a winch drum would only have one bend-unbend per cycle. Experimental data, including applied and measured loads and piston displacements were recorded with a sampling frequency of 1 Hz. The belt was subject to a freshwater spray to imitate the thermal effects of submerged operation. An IR camera was used to compare surface temperatures between 5 points on the belt and a reference point on the sheave at intervals throughout the test. Testing was scheduled to continue constantly for 3 full

weeks although ultimately only 2 weeks of total sample excitation was achieved. The test setup is shown in Figure 2.

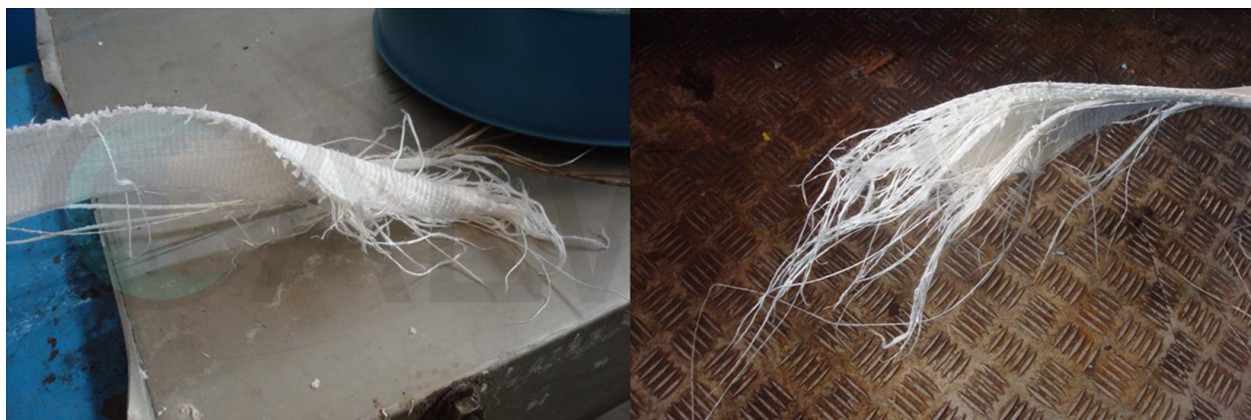
Figure 4: Belt after complete failure.

To continue to make use of the 3-week allotted testing time and acquire more data, the sheave and belt were both flipped such that the damaged ends were on the top and reinstalled onto the machine. Testing was then restarted on January 30th following the same testing conditions. Complete belt failure occurred after 78,600 total machine cycles (157,000 bending-unbend cycles) after an additional 18k cycles since restarting the experiment caused the belt to break along its full width. The torn areas of the belt can be seen in Figure 4. The belt also exhibited some delamination upon failure suggesting a layered cross section construction as opposed to fully weaved.

The belt failed prior to enduring 100k cycles and fell short of the targeted millions of cycles. However, although the intent of the experiment was to test the CBOS performance of the HMPE belt, the actual failure mechanism appeared to be caused by abrasion along the belt edges due

to the belt not fitting properly inside the sheave. A properly sized belt and sheave pair is expected to significantly increase the belt life. The delamination of the belt brings to question whether a fully woven cross section would be more robust than the layered one. It is also expected that upgrading to a branded fiber, such as DSM's Dyneema or Honewell's Spectra, could increase fiber performance. Fiber manufacturers also have developed special coatings such as DSM's XBO coating which claim improved CBOS performance. Additional testing on an improved belt and sheave that incorporates the learnings is considered before the technology can be implemented in a scaled deployment reliably.

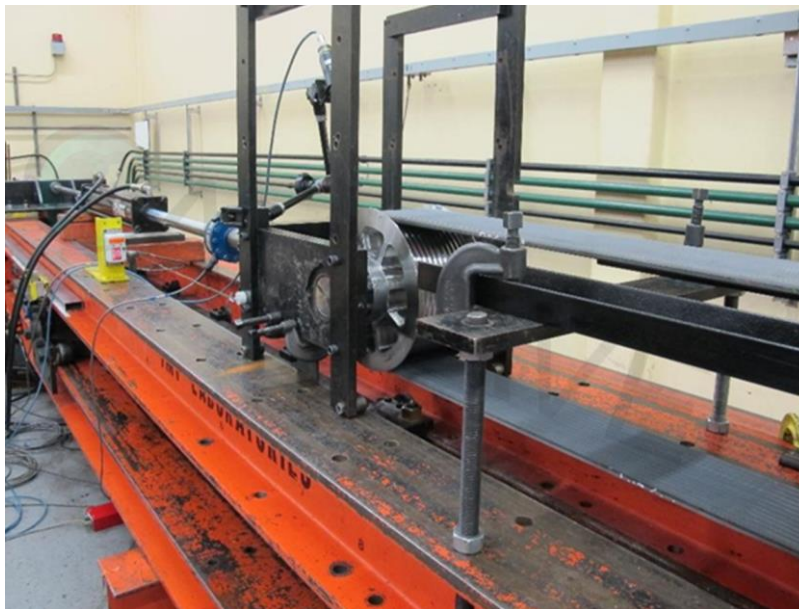
Figure 8: Tensioning drum clevis assembly attached to load cell and hydraulic tensioning cylinder.

Photographs of the realized test stand with the steel cable belt samples can be found in Figures 4 - 6. A load cell is installed on the tensioning cylinder rod end to measure cylinder induced tension, shown in Figure 8. A string potentiometer measures the cylinder displacement. To help support the weight of the belt terminations, support trolleys that ride along the steel frame were added, shown in Figure 9. Infrared (IR) temperature measurement sensors were installed to measure belt surface temperature on both the drive and tension drums, as shown in Figure 10.

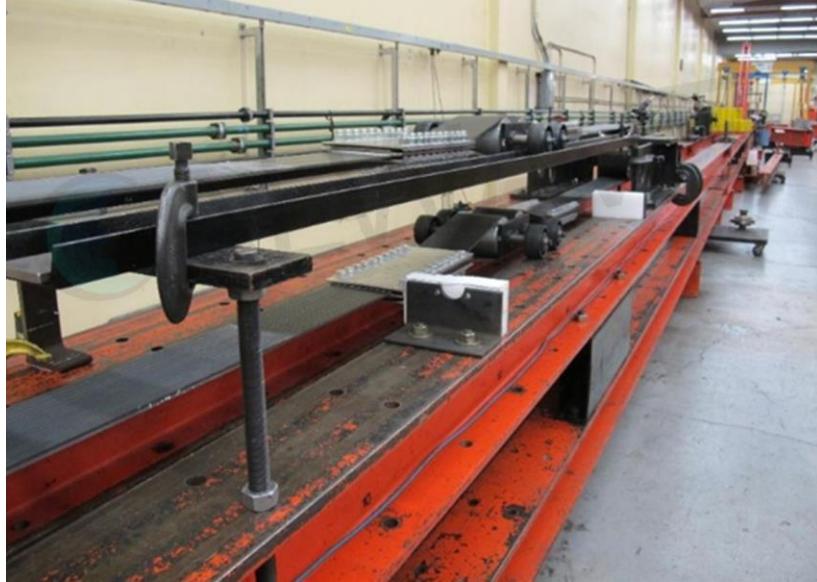
Figure 9: Belt samples attached to termination support trolleys.

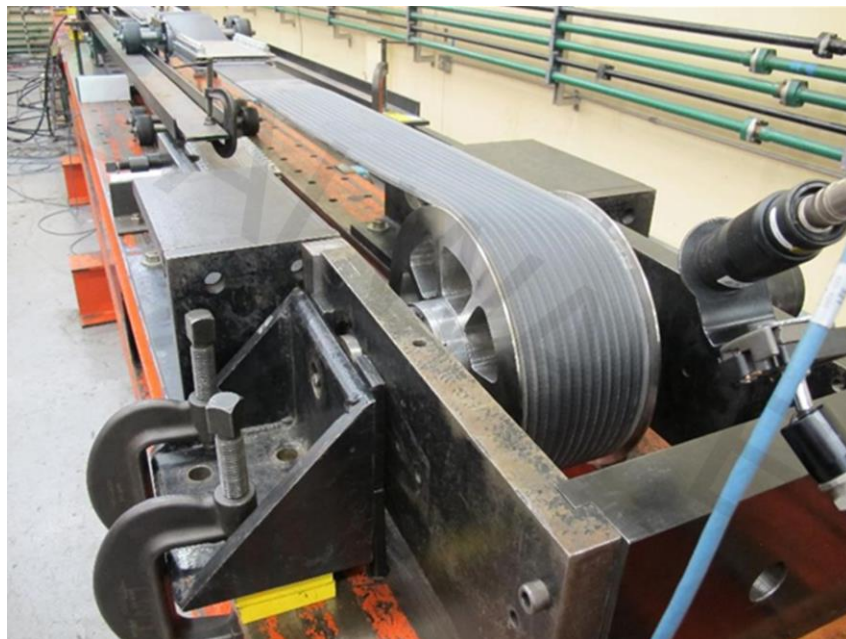
Figure 10: Drive drum and IR temperature sensor

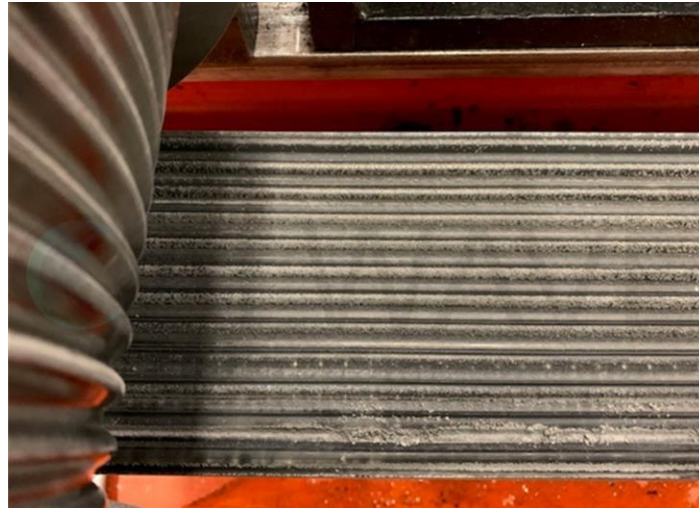
Figure 12: Drive belt wear in double bend zone after 750,962 cycles. Greatest wear on the near edge of the belt.

For cycle block 8, the fleet angle was increased to 1.0 degree, and the normalized belt tension was set to 0.089. The duration of this cycle block was 153,500 machine cycles. The temperature of the drive belt sample remained approximately 3 degrees C above the temperature of the tension belt sample. By the end of cycle block 8, wear from a total of 750,962 cycles had accumulated on the belt samples. The photographs in Figures 8 and 9 show the drive belt sample wear debris accumulated by the end of cycle block 8. The accumulated belt debris was mainly the result of belt rib wear produced as one side of each rib rubbed against the mating side of its drum groove. The lateral thrust of the belt ribs against the drum grooves was due to the belt fleet angle. Note that this debris was not artificially disturbed throughout the series of tests. The tension belt sample appeared undamaged at the end of cycle block 8.

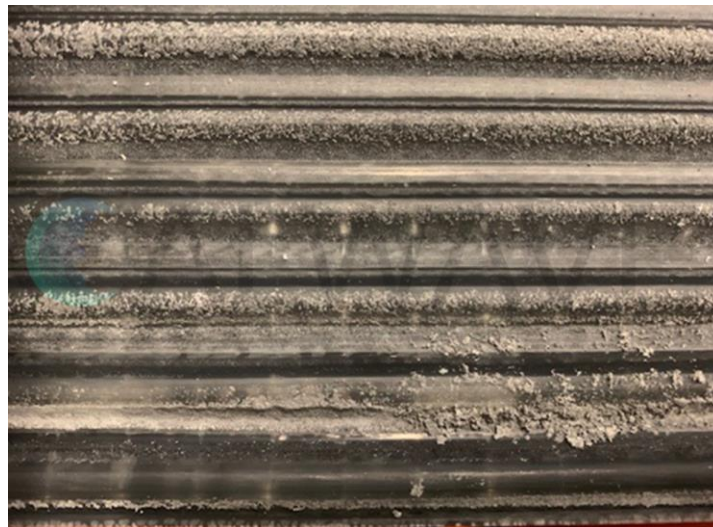
Figure 13: Close up of Figure 12 showing wear. Accumulated powder residue thought to be worn polyurethane debris.

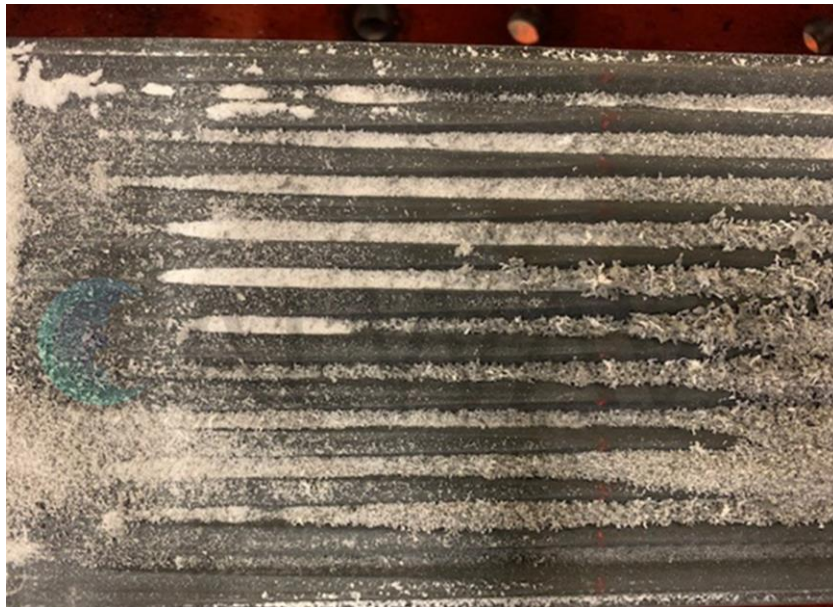
Figure 15: Belt wear residue at 847,612 machine cycles.

the cycle block progressed, the temperature difference diminished to approximately 25 degrees, likely due a changing belt wear pattern on the drum. The test was stopped after a cumulative total 847,612 machine cycles. This final cycle block produced enough additional belt wear to expose two steel cables on the belt face at the high-tension edge, shown in Figure 14. Another steel cable was exposed along the low-tension edge of the belt due to contact with the drum flange. Resulting polyurethane wear residue can be seen on the belt sample in Figure 15 and on the drive drum in Figure 16. The test was deemed complete at this point because of the belt damage. The companion belt sample on the tension drum remained undamaged at the end of the test program.

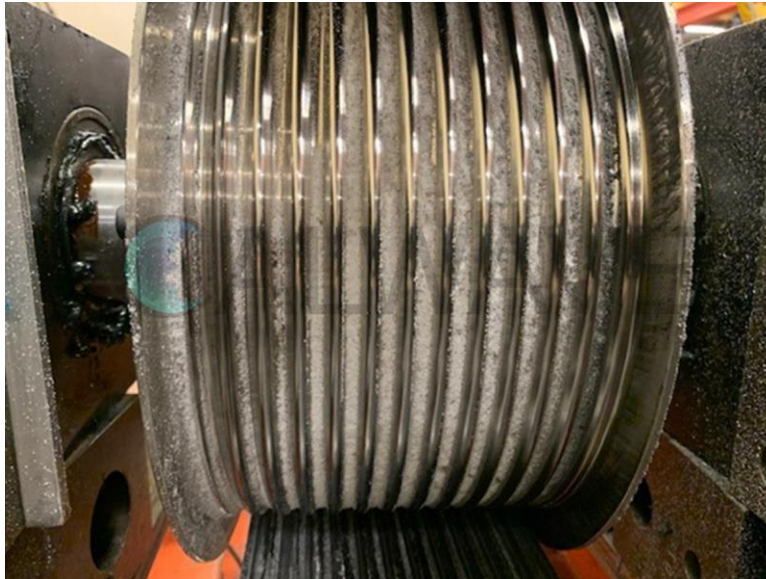
Figure 16: Belt wear debris in drum grooves at 847,612 machine cycles.
