# **KVICHAK RIVER RISEC PROJECT**

## **Resource Reconnaissance & Physical Characterization**

### **Final Report**

**Kvichak River, Vicinity of Igiugig, Alaska**

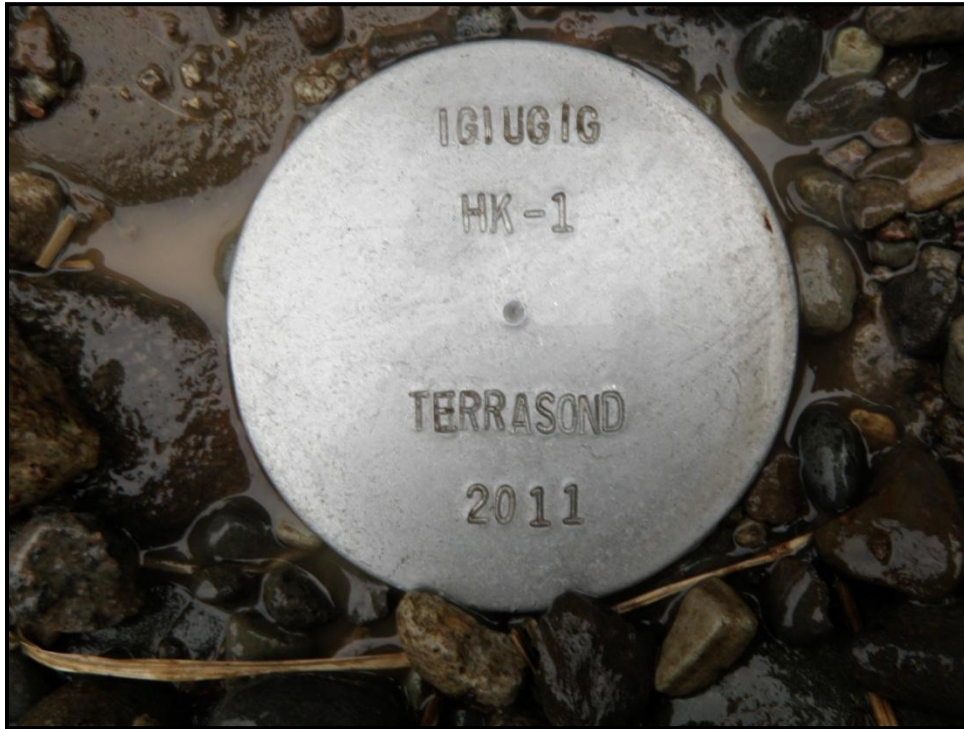
**Figure 5 – Monument HK-1.**  
3 ¼ inch aluminum cap on rebar.

After assessing the field site the survey crew determined that the best location for the primary control monument was in the vicinity of the Fish and Game Boat Landing. This location was selected because of its central location in the project area, ease of access, good line of site for broadcast of RTK correction signals, and stable soils. Two monuments were set at this location. The first monument was designated “*HK-1*.” It was a 36 inch x ¾ inch piece of rebar with a domed 3 ¼ inch aluminum cap stamped “*IGIUGIG HK-1 TERRASOND 2011*.” The selected location was a grassy section on the side of a knoll between the upper parking area and the boat landing. The final set was 0.4 feet below grade. Figures 5, 6. The second monument was set for vertical reference. It has been designated as “*HK-V*”. It was comprised of four sections of ½ inch x 4 foot steel drive rod with a bullet head center threaded at the top. The rod was driven until met with refusal at approximately 16 feet. This monument was set 0.2 feet below grade at the top of the hill on the east shoulder of the road leading from the school to the boat landing, Figure 7, 8. A group of small sized cobbles with one large cobble were set around and over both monuments for protection.

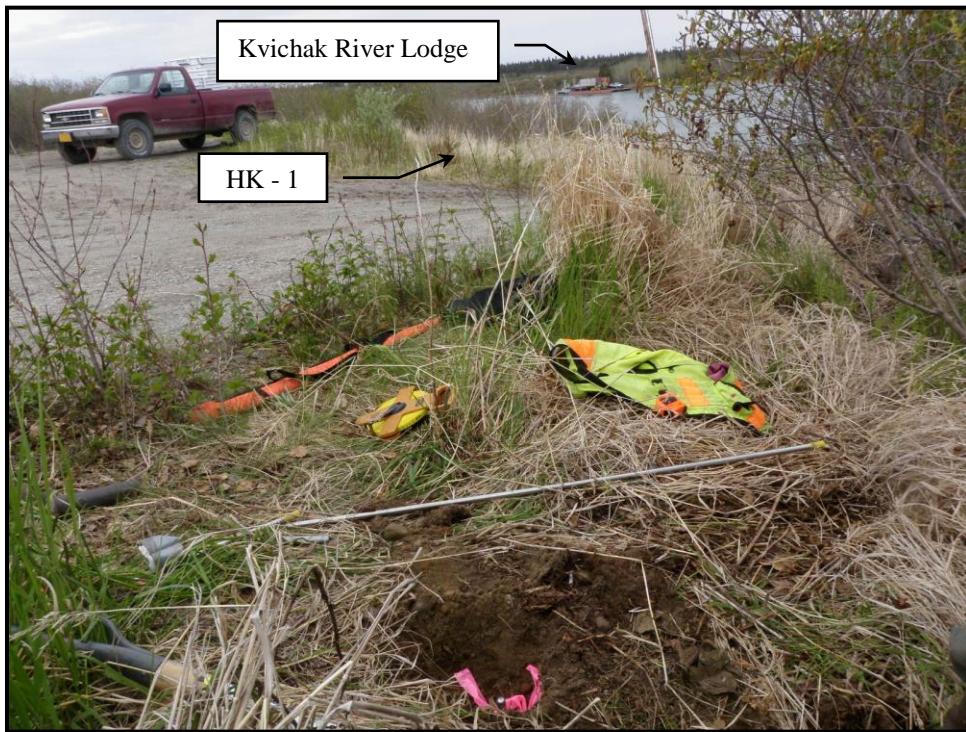
**Figure 8 – View from HK-V.**

View to the northwest across the road toward the Fish and Game boat landing and HK – 1.

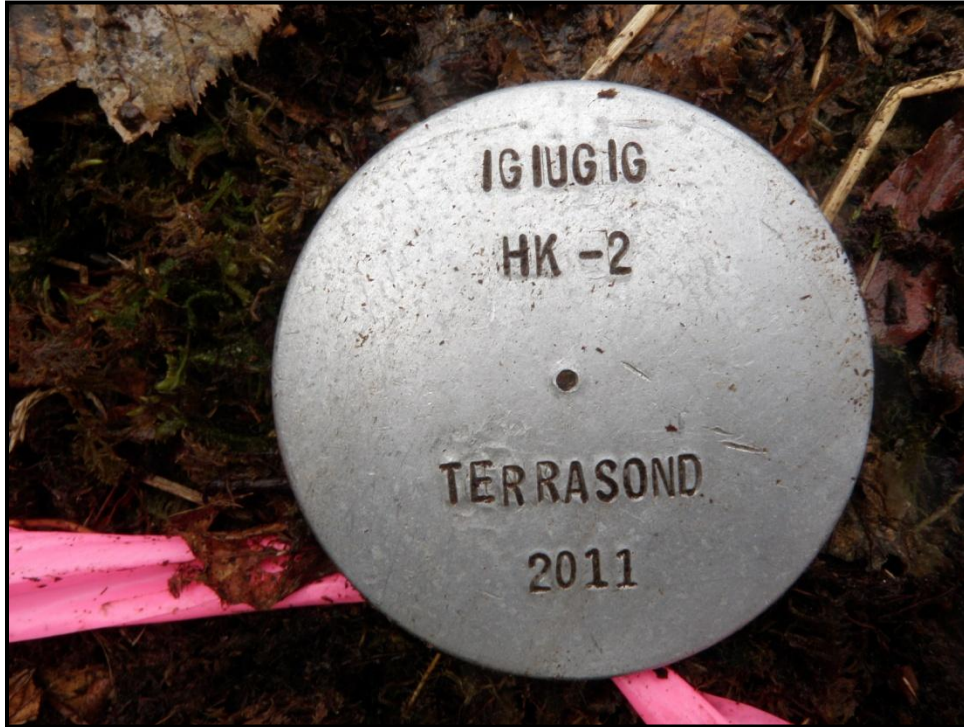
**Figure 9 – Monument HK-2.**

Three additional monuments were set for the purpose of monitoring the river water level and as possible base station locations. Monument “HK-2” was established with a 3¼ inch domed aluminum cap marked “IGIUGIG HK-2 TERRASOND 2011” on 36 inch x ¾ inch rebar. It was set three quarters of the way down the bank from the west fence corner of the fuel tank containment by the electric generation plant, Figures 9, 10. Sloughing of the bank that occurred between 2 September and 11 October 2011 has destroyed this monument.

3 ¼ inch aluminum cap on rebar. (Destroyed.)

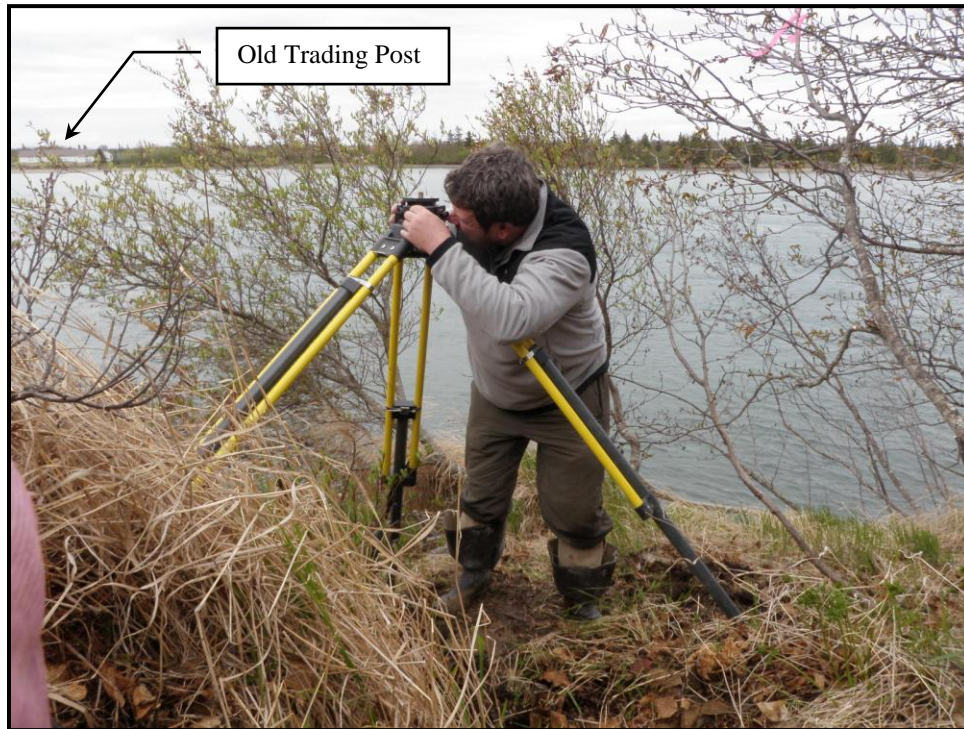
**Figure 10 – View to the northwest across the Kvichak River from HK-2.**  
(HK-2 was Destroyed.)

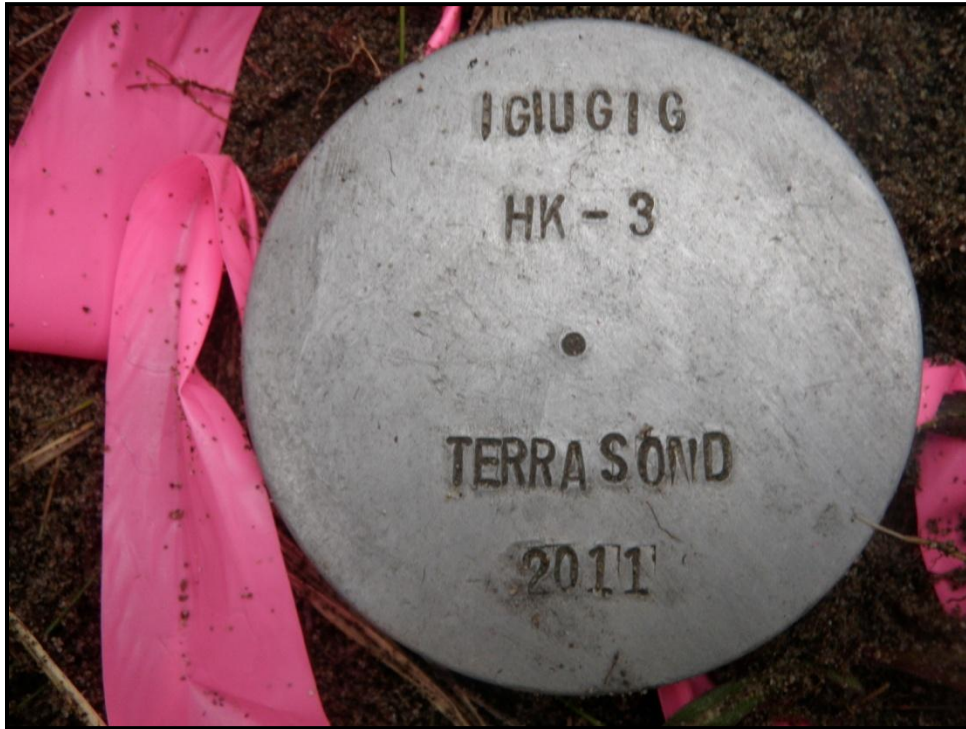
**Figure 11 – Monument HK-3.**  
3 ¼ inch aluminum cap on rebar.

Monument “*HK-3*” was placed on a level spot at the base of a 3 meter bluff of moderate repose on the left bank in the vicinity of the Kvichak River mouth. It was topped with a 3 ¼ inch aluminum cap that was stamped “*IGIUGIG HK-3 TERRASOND 2011*” The final placement was 0.4 feet below grade. It was concealed under several medium cobbles, Figures 11, 12.

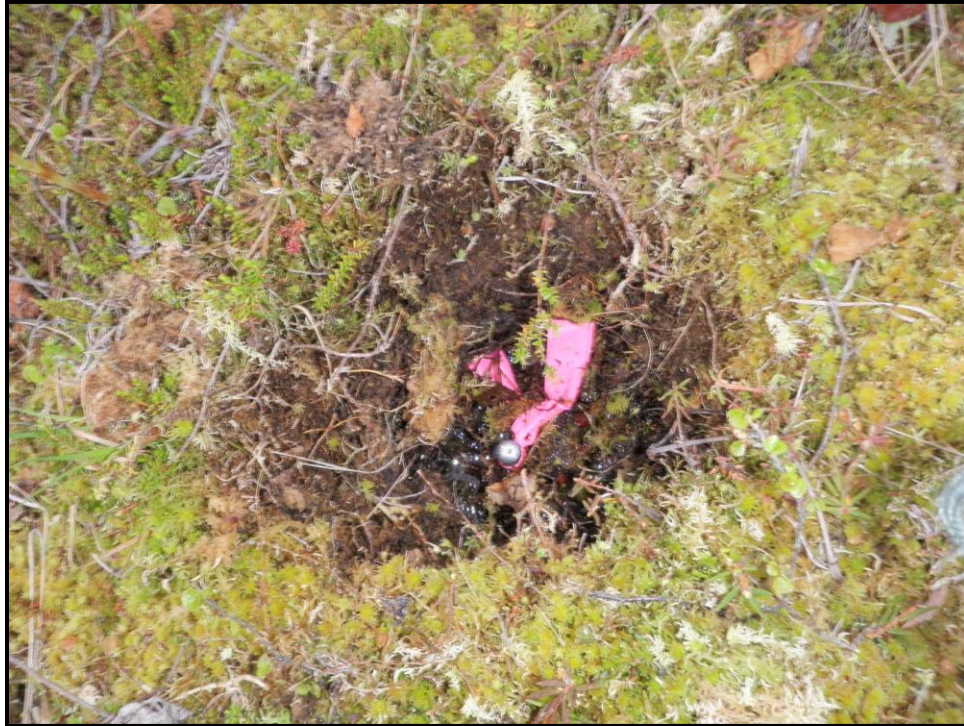
**Figure 13 – Monument HK-4.**  
½ inch x 8 foot steel rod with bullet top.

The final monument was placed near the downstream extent of the initial project area. Two pieces of ½ inch x 4 foot drive rod were driven and topped with a bullet head. It has been designated “HK-4”. The monument was established in a small level clearing approximately 35 feet shoreward of the left bank. Figure 13, 14.

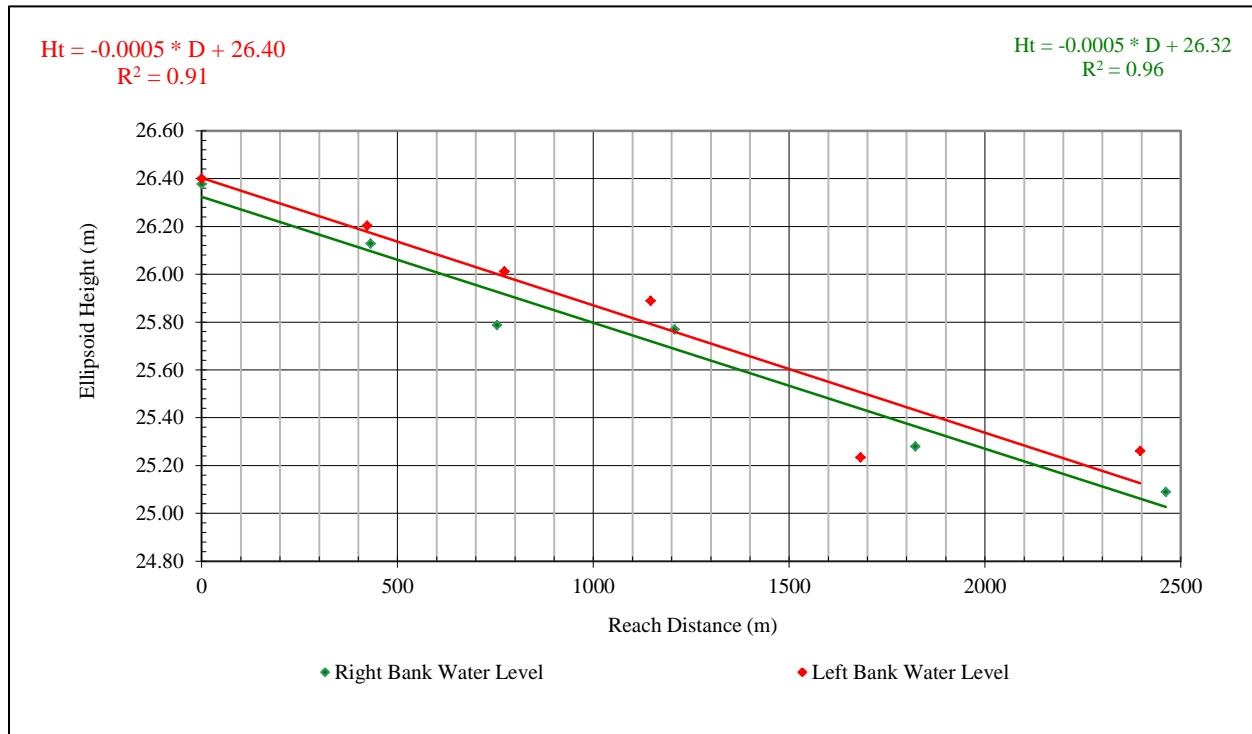
**Figure 17 – Linear regression of water level slope.**

On 18 June 2011 a set of water level measurements were made using a Leica 1200+ series RTK GPS rover unit. The water levels and horizontal positions were placed in an Excel 2010 spreadsheet and the ellipsoid heights were regressed to a line with respect to reach distance, Figure 17.

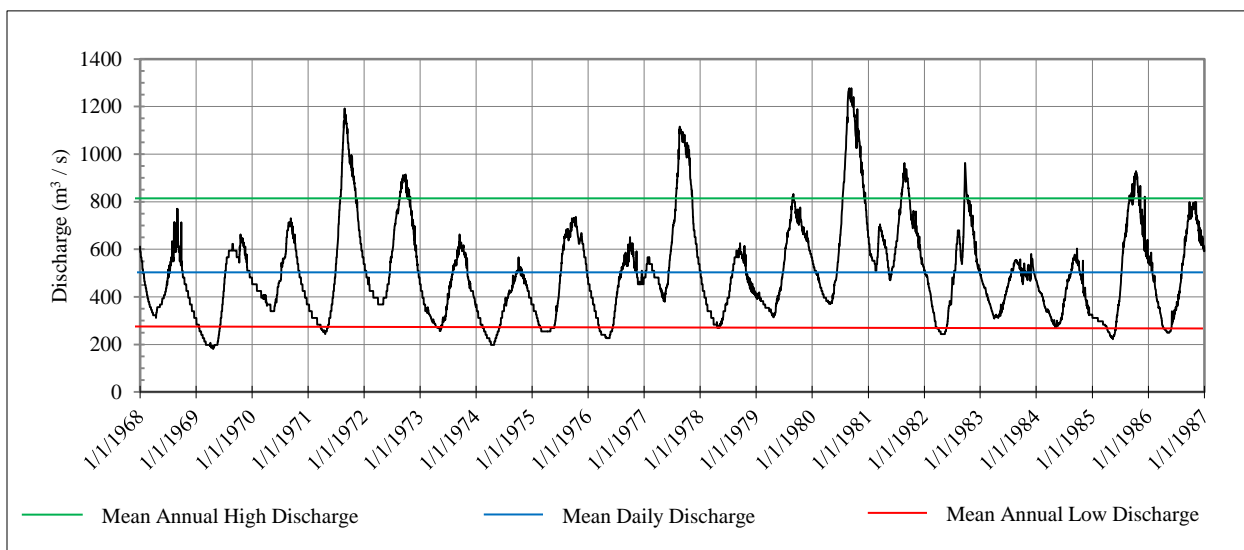
**Figure 18 – USGS Site 15300500 daily discharge.**

The USGS operated a gaging station on the Kvichak River at this location from 1967 to 1987. It was designated Site 15300500. During this time they completed 39 discharge measurements and developed two rating curves. This rating curves were used by the USGS to make daily estimates of discharge. The USGS published these estimates from 1 January 1967 to 1 January 1987. Unfortunately the original RM's for the gaging station have been lost. Further, the river channel has experienced some changes in dimension and flow pattern over the last 24 years. Nonetheless the USGS gaging data has been of some utility in characterizing the current discharge. This data set shows that the typical low discharges have occurred between the middle of March and the middle of April, Figure 18. The high discharges have usually occurred between late August and early October.

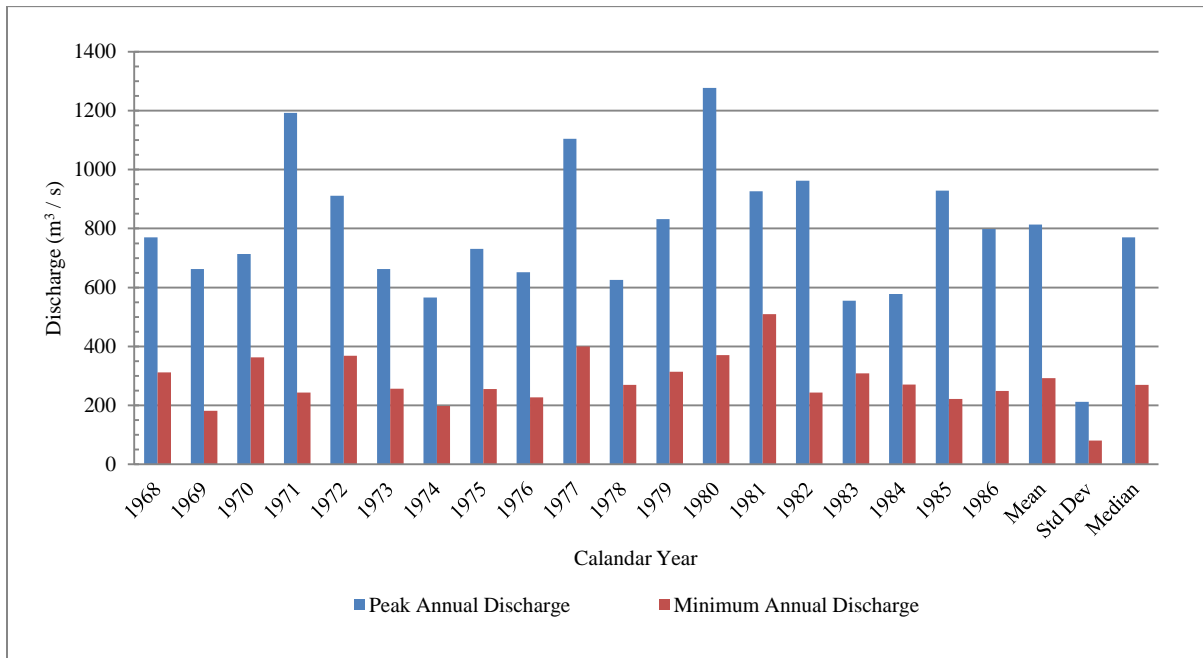
**Figure 19 – USGS Site 15300500 annual maximum and minimum discharge.**

The USGS normally used a river year that corresponds with the U.S. fiscal year to define the period for selecting annual descriptive statistics. This approach was not useful for current analysis because it resulted in annual extremes being designated within weeks of each other in the same calendar year. Therefore it was decided to use the calendar year for river analysis in this report. The annual peak and minimum discharges that have been presented in Figure 19 were determined from the USGS gage data for the respective calendar years.

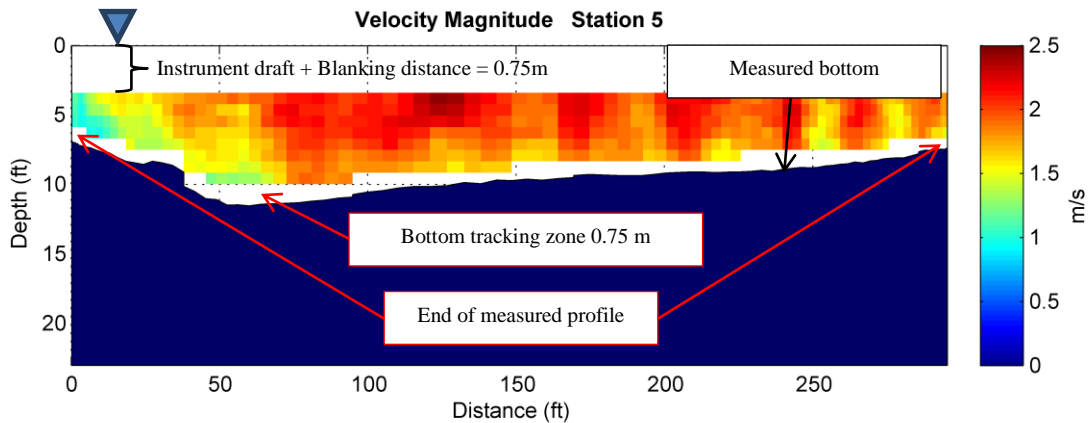
**Figure 20 – Omitted zones of ADCP profiles.**

The TRDI WorkHorse Sentinel 1200 kHz ADCP used for this project was mounted vertically on a pole with the transducer head 0.5 meters below the water surface. When the transducers ping the sound is emitted in all directions. Thus there is a simultaneous return from the water column and the instrument housing. Because of this the instrument cannot distinguish between returns in the first 0.25 meters in front of the transducer head and the returns from the housing. Therefore no measurements are recorded for the region that extends from the transducer head to a point 0.25 meters distant. This distance is known as the blanking distance. The combined draft and blanking distance for the data presented here is 0.75 meters, (2.46 ft.). Therefore there are no direct measurements of current velocity recorded for the first 0.75 meters of the water column. A small portion of the bottom of the water column does not have direct current velocity measurements. This is due to issues with backscatter from the bottom and the need to use bottom tracking to determine vessel movement. In the data presented here the bottom gap is 0.75 m, (2.46). However, the ADCP does measure the actual depth to the river bed. Due to the instrument draft and blanking distance the ADCP cannot be maneuvered all the way to the shore. There must always be at least 0.75m (2.46) between the transducer heads and the river bed. Therefore, the profiles presented in this report represent the portion of the channel that was surveyed directly by the ADCP. There is a small sliver on each side of the channel that is omitted. In order to make an extrapolation to compute the discharge in the side slivers the ADCP is held in position for about 10 seconds as close as possible to the bank while also maintaining at least two good measurement bins below the instrument. Thus the shallowest water that this instrument configuration can measure is 1.30 m (4.26 ft). While holding position near the bank the distance from the instrument to the bank is measured and recorded in the data record. The sampled bins and the bank distance are used to extrapolate a value for discharge in the omitted sliver at each bank, Figure 20.

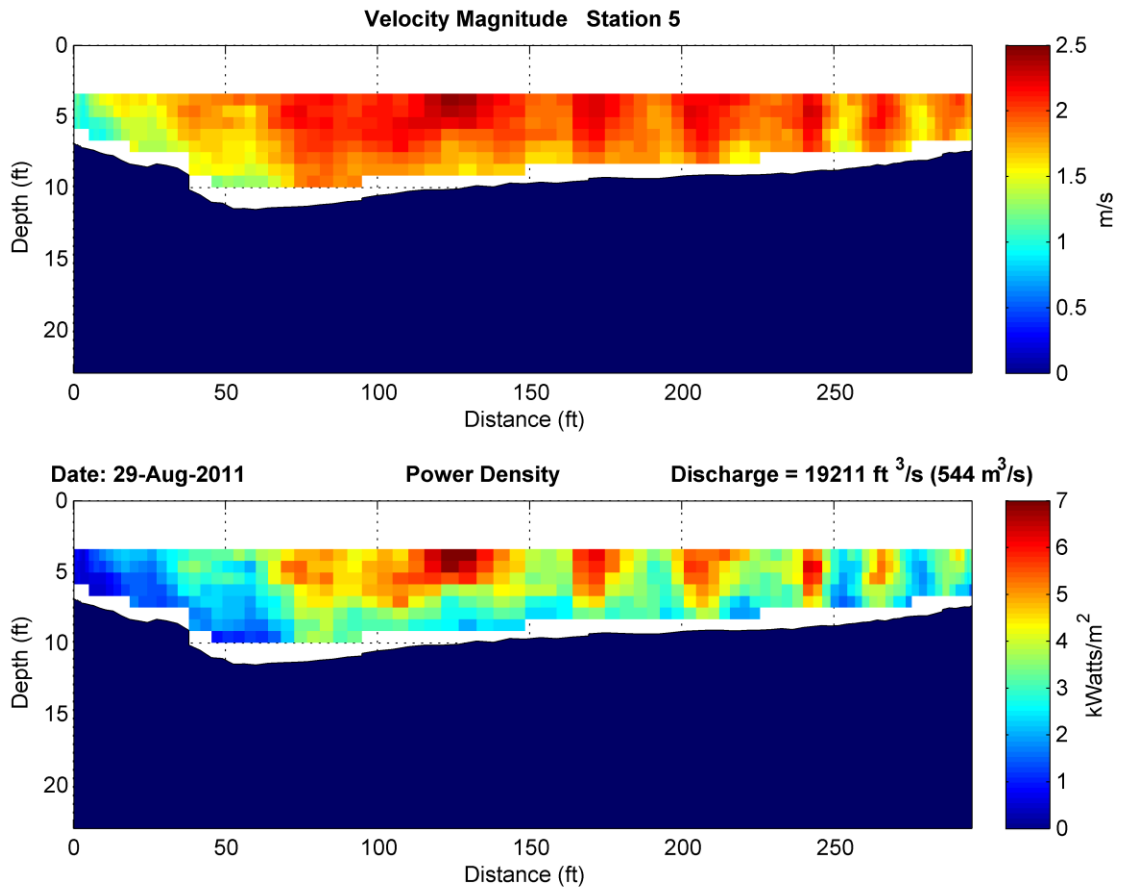
The June ADCP transect at Station 5 exhibits a zone of low to moderate power density that is centrally located in the channel. Its left extent is offset to the right of the thalweg by about 10 meters. From there it extends to the right of the channel such that it ultimately occupies the central two thirds of the river. The overall distribution of power at this station appears to remain the same at the higher discharge rates. Average velocity magnitude at Station 5 was 1.6 m/s on 21 June 2011, 1.8 m/s on 27 August 2011, and 1.7 on 12 October 2011. At the lower discharge the power density ranges from about 2 to 4 kW/m<sup>2</sup>. At the higher discharge the range energy density in this zone is from approximately 4 to 6 kW/m<sup>2</sup> Figures 21, 22, 23.

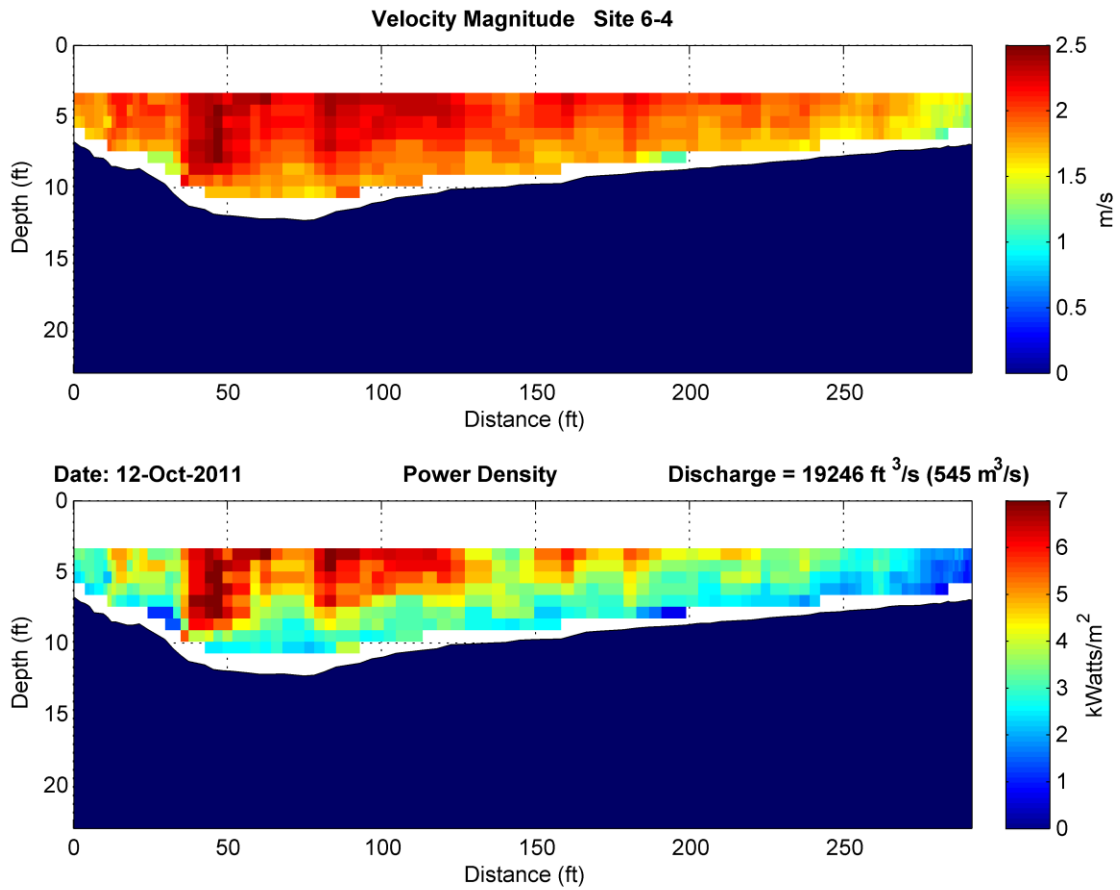
From Site 6-3 to Site 6-6 the thalweg expands to the right and the channel starts to develop a profile that has a steep slope from the left to a low point at 15 meters from the left bank. Then there is a gradual slope up to the right bank. A zone of elevated energy density develops on the left side of the river, Figures 29, 30, 31.

The channel expansion continues and a zone of higher energy density develops in the vicinity of the thalweg.

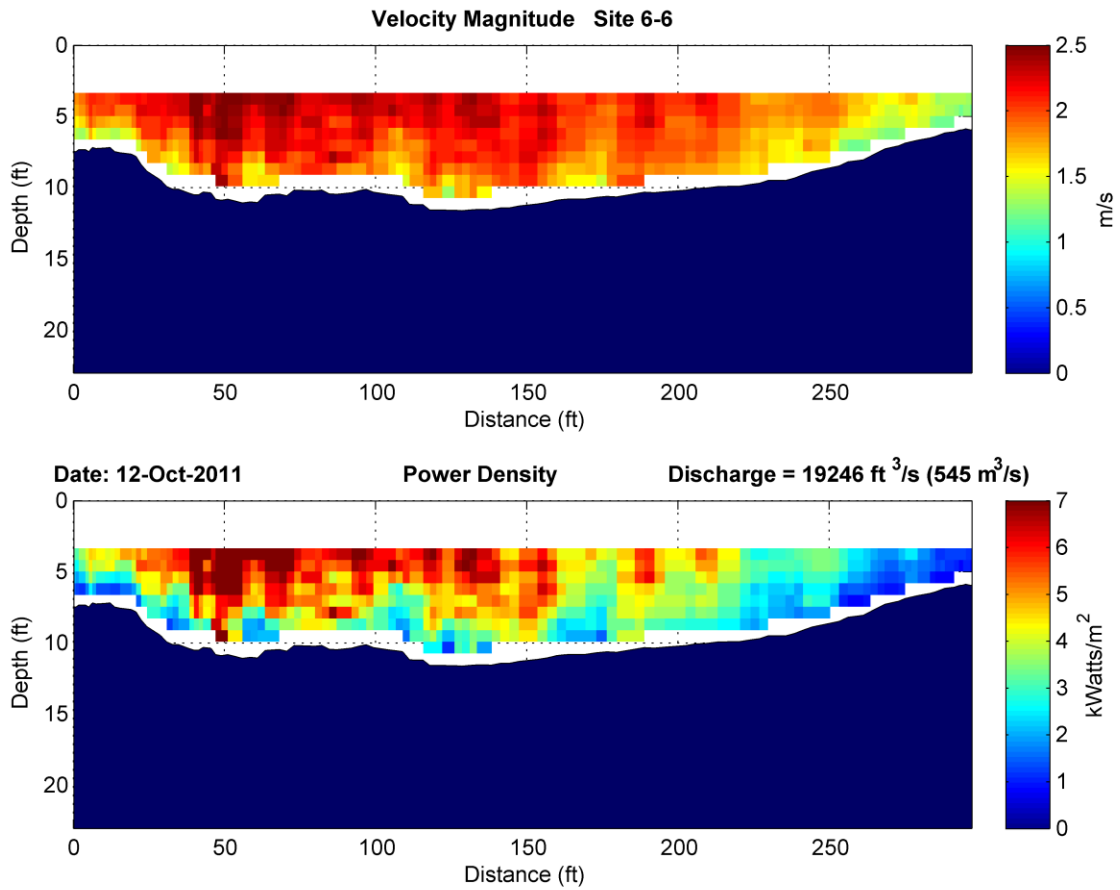
At Site 6-6 the channel expands on the left and right side. The high energy density increases intensity and expands to occupy the majority of the left half of the channel. At Site 6-7 the channel is filled in on the left and continues to excavate on the right. The zone of elevated energy density remains largely the same as in the upstream transect. At Site 6-8 the left side is excavated again and the right side continues to be excavated. The overall profile has moderately steep slopes on the left and right with a flat bottom that comprises the central half of the channel. The elevated energy density persists to the left half of the channel, Figures 32, 33, 34.

The channel expansion continues and the zone of higher energy density expands to occupy the left half of the channel.

At Site 6-7 the channel is filled in on the left and continues to be excavated on the right.

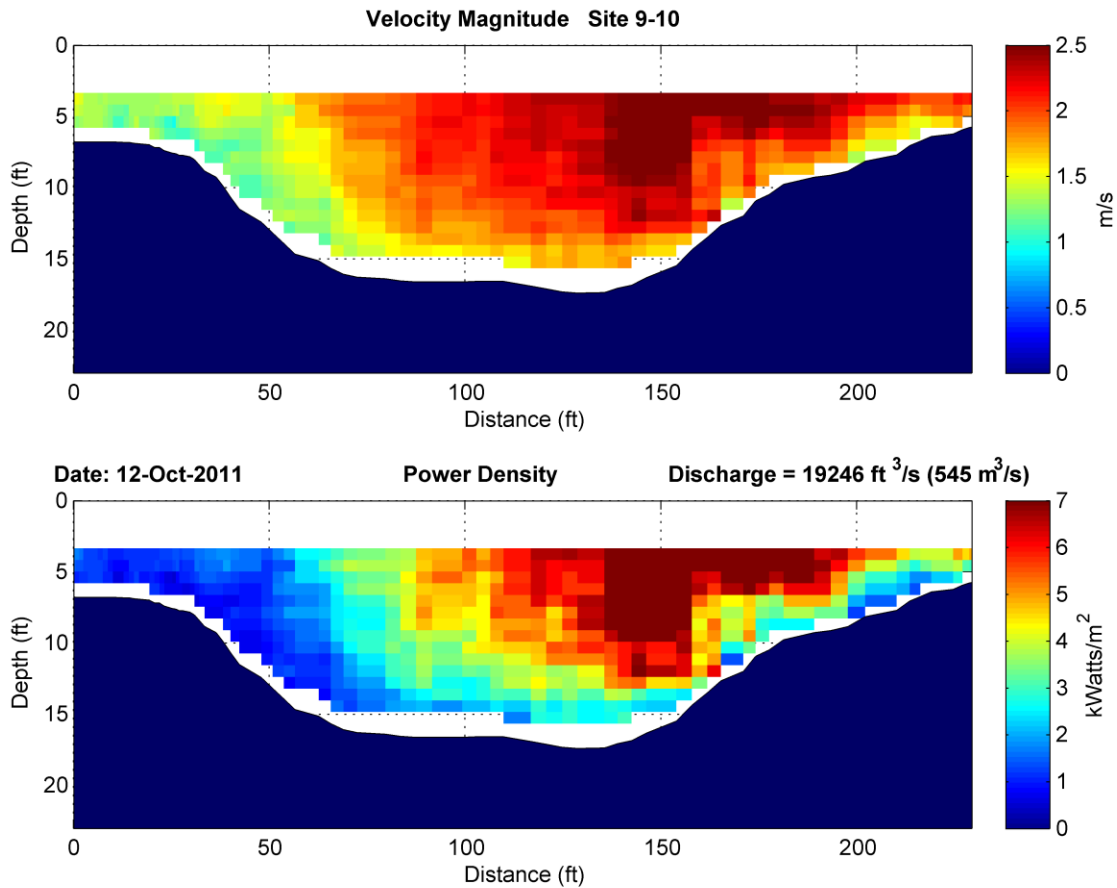
By Site 9-8 the well defined central thalweg starts to give way to a broad flat bottom that rises with steep slopes to the left and right banks, Figure 43. With further progress downstream this zone tends to align with the thalweg and the energy density rises. As the thalweg becomes wider the high energy density zone expands and becomes more intense, Figure 44. By Site 9-10 the high energy zone dominates the right side of the channel. The energy density in the zone is between  $5.5 \text{ kW/m}^2$  to  $7 \text{ kW/m}^2$ , Figure 44.

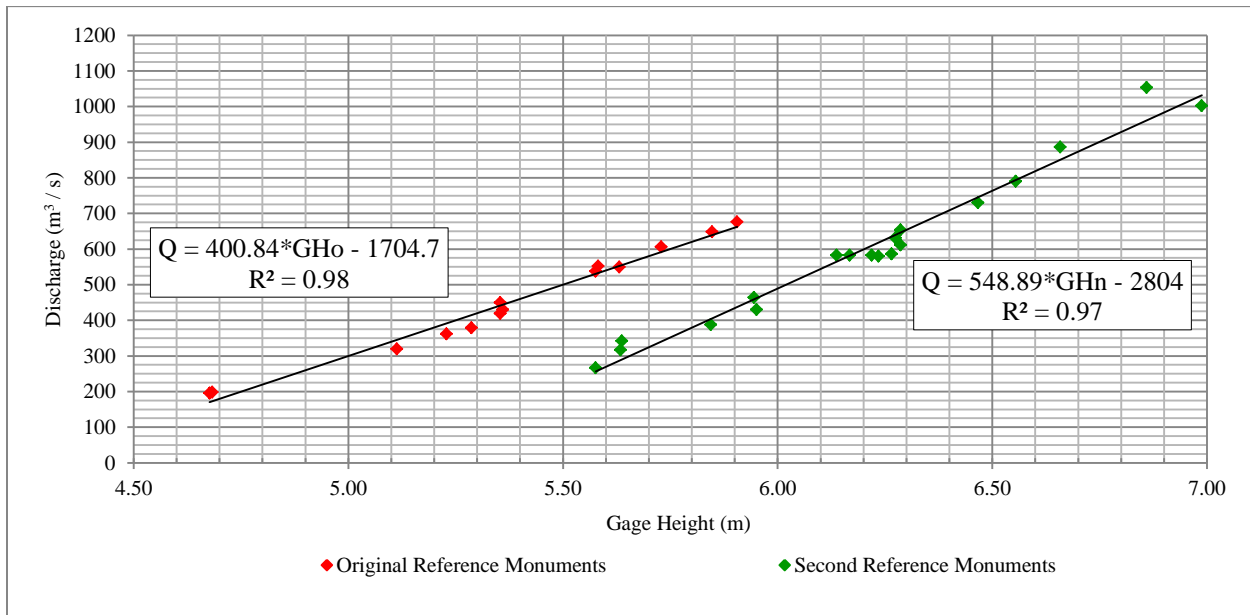
**Figure 51 – USGS discharge versus gage height with respective regressions.**

The USGS Gaging Site 15300500 was established at Igiugig on the Kvichak River on 15 June 1967. It was operational until 1987. The methods used at the time were published in Techniques of Water-Resources Investigations of the United States Geological Survey, Chapter A8, Discharge Measurements at Gaging Stations, Book 3, Applications of Hydraulics, 1969. During this time they did 39 discharge measurements. The USGS used these measurements to establish a set of rating curves for the site. There were two sets of RM's used for the river gage height. Both sets of RM's originated from an assumed arbitrary value. By coincidence the values selected for both references were close. The first set was used for measurements 1 to 16. Measurements 17 to 39 were completed using the second set of RM's. The exact date that the USGS switched RM's is not certain. It was most likely sometime between discharge measurement 16 and 17. These measurements took place on 28 September 1970, and 24 March 1971. There was no mention in the USGS station records of a level loop being done to tie the two sets of RM's together. Nonetheless the USGS appears to have adjusted the gage heights for discharge measurements 8 to 16 and carried them forward to the later rating curves, Figure 51.

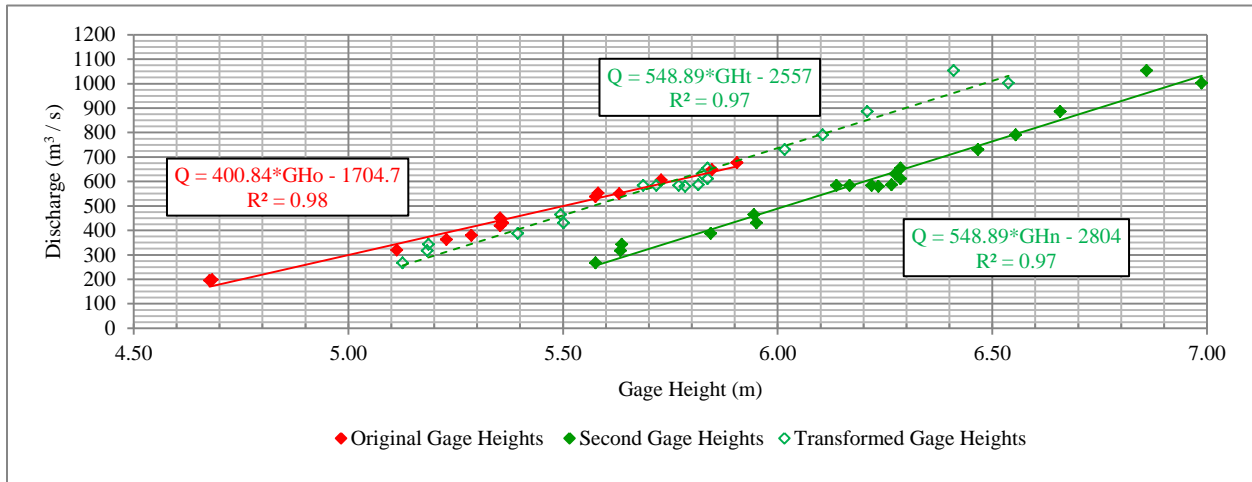
**Figure 52 – Regression of USGS discharge measurements.**

conformally. This is confirmed by demonstrating that the slope of the regression for the transformed discharge data is parallel to the first regression, Figure 52.

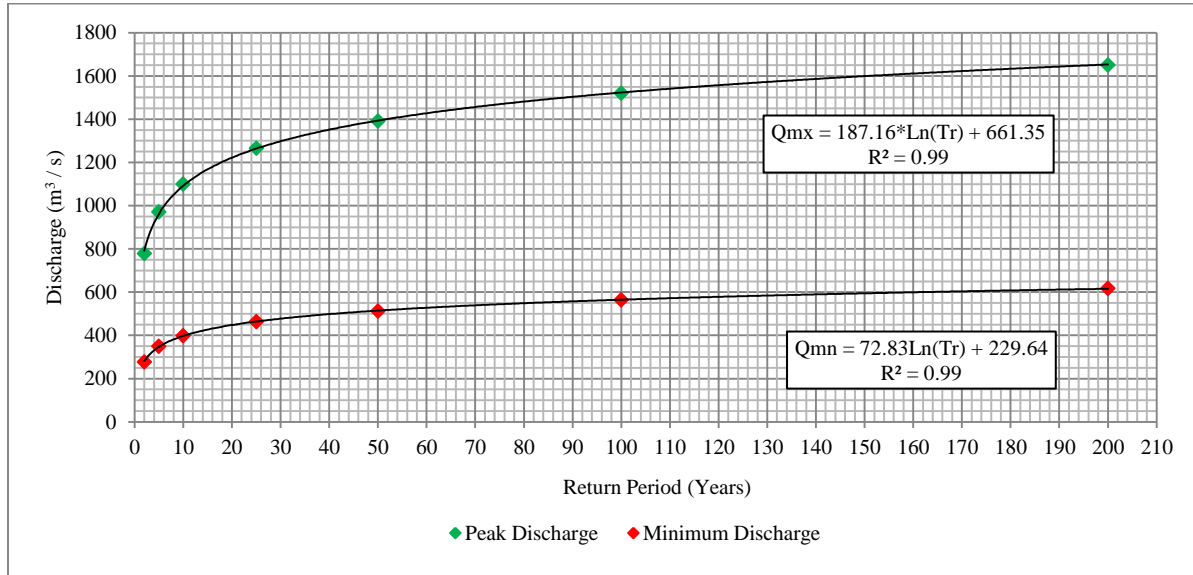
**Figure 59 – Plot of discharge return period for the Kvichak River at Igiugig.**
