RivGen Open Water Deployment Report

<b>2019 RivGen Open Water Deployment Report</b>	<b>Document Number</b>	<b>RS-RV20-10731</b>
		<b>Award Number</b>	<b>DE-EE0007348</b>
		<b>Project</b>	<b>IVC DOE RivGen</b>

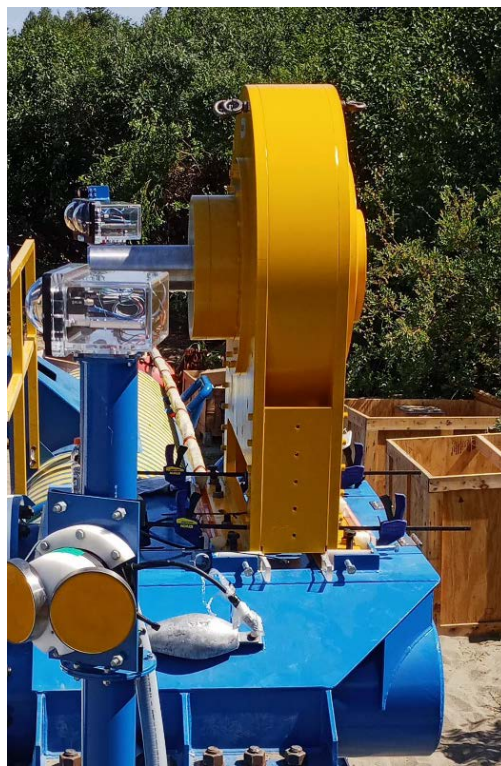
On June 22, ORPC contracted Tern-Tech of Anchorage, AK, to validate the alignment of the components of the power take off system. They focused on the alignment of the mechanical brake, which had not previously been installed due to delays in manufacturing. Prior to Tern-Tech’s arrival, ORPC and ILC implemented several low-cost alignment techniques, including straight edges and tensioned strings. Although these techniques were not sufficient for a final alignment, they significantly reduced the time required by Tern-Tech. After only a half day, Tern-Tech was able to validate that the alignment was within 0.050 in.; alignment of the other driveline components was also re-checked with the equipment and time on hand. Once the alignment was verified, the mechanical brake was set in place using Chockfast (Figure 8). All other driveline components were completed with Chockfast during initial system integration in Brunswick, ME.

Figure 8. Installation of Chockfast between the mechanical brake and the chassis

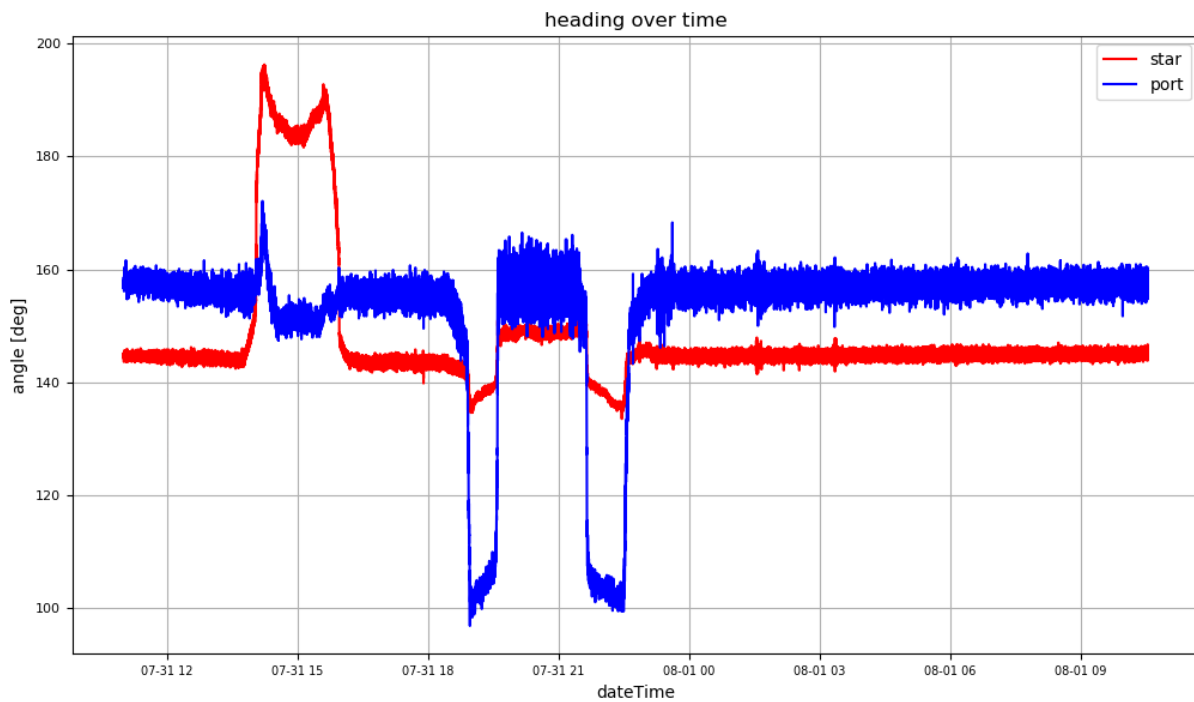
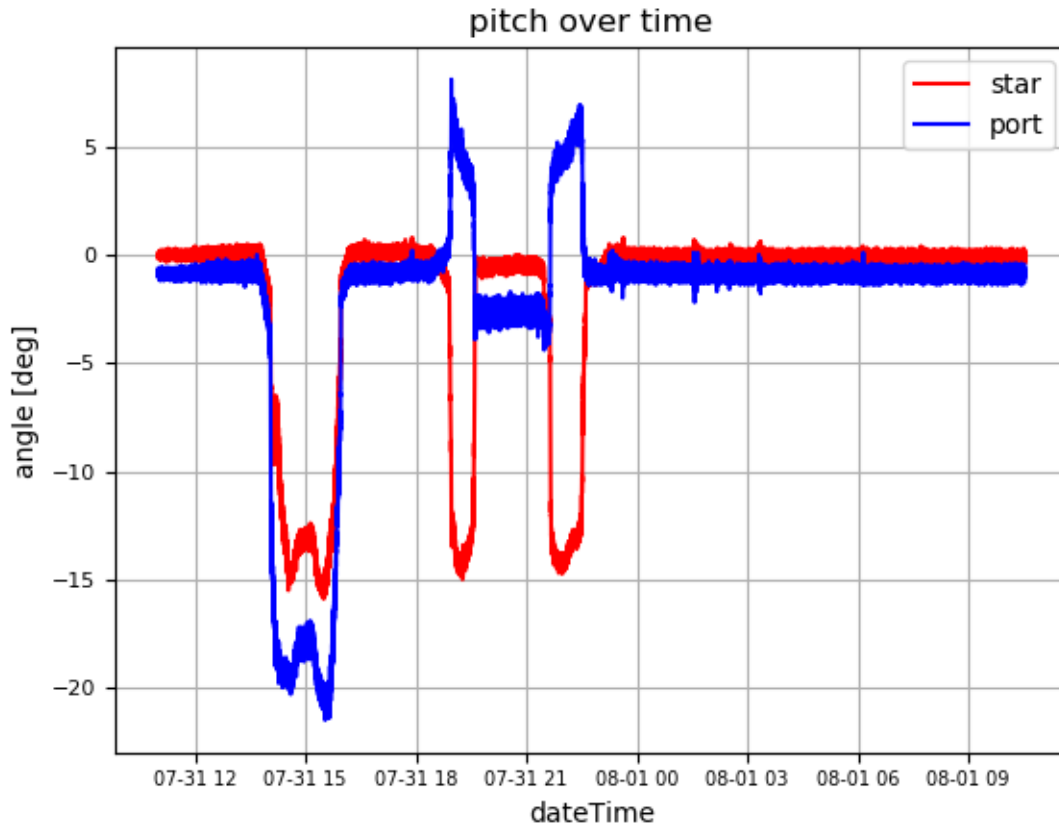
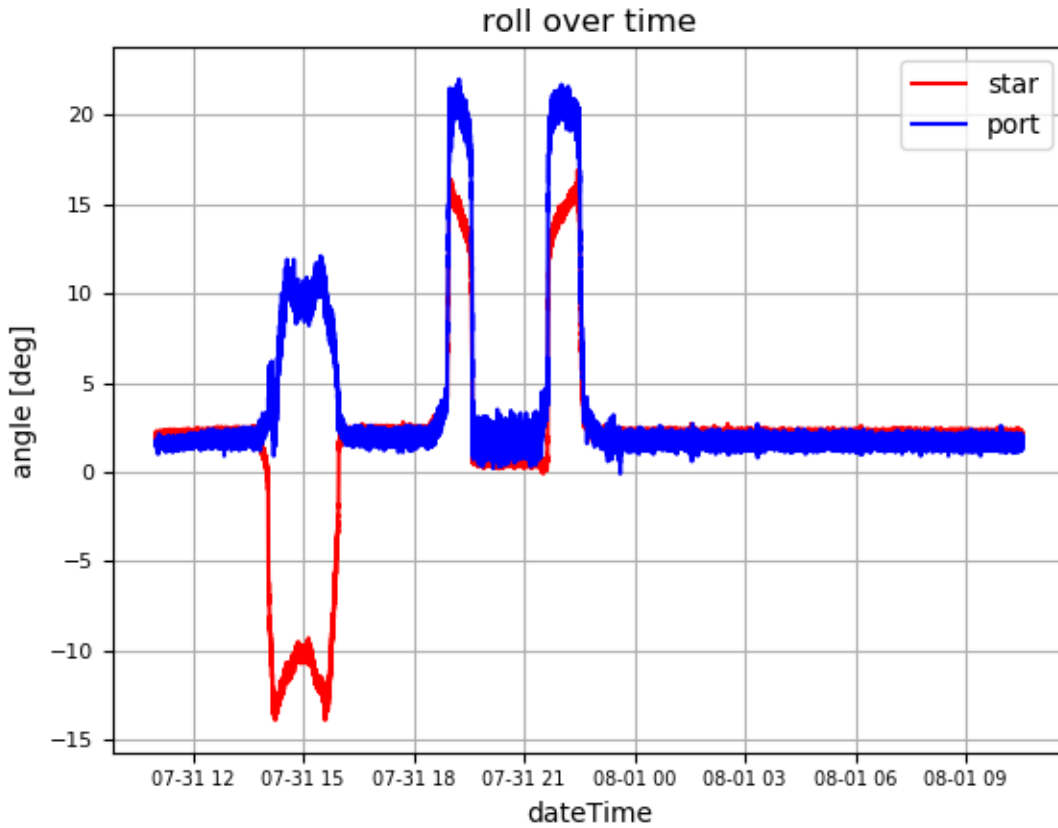
All of these were successful except for the bow-down deployment (Figure 27). In the deeper water of the river, with the bow down, the water in the partially filled aft pontoon chambers covered the air vacuum pipe prior to sufficient filling to sink the aft end. As a result, the bow was able to fully submerge; however, the aft end was not. This was due to the layout of the pontoon's internal plumbing. Once the cause of the issue was identified, the partially deployed device was retrieved without issue.

Figure 28. AWAC heading measurements during deployment tests. First peak represents the attempted bow-down deployment. The second peak represents the side pivot launch deployment. Note: AWAC measurements are skewed due to 25deg (starboard) and 40deg(port) offsets of AWACs for velocity measurements.

Figure 29: AWAC pitch measurements during deployment tests. First peak represents the attempted bow-down deployment. The second peak represents the side pivot launch deployment. Note: AWAC measurements are skewed due to 25deg (starboard) and 40deg (port) offsets of AWACs for velocity measurements.

Figure 30: AWAC roll measurements during deployment tests. First peak represents the attempted bow-down deployment. The second peak represents the side pivot launch deployment. Note: AWAC measurements are skewed due to 25deg (starboard) and 40deg (port) offsets of AWACs for velocity measurements.

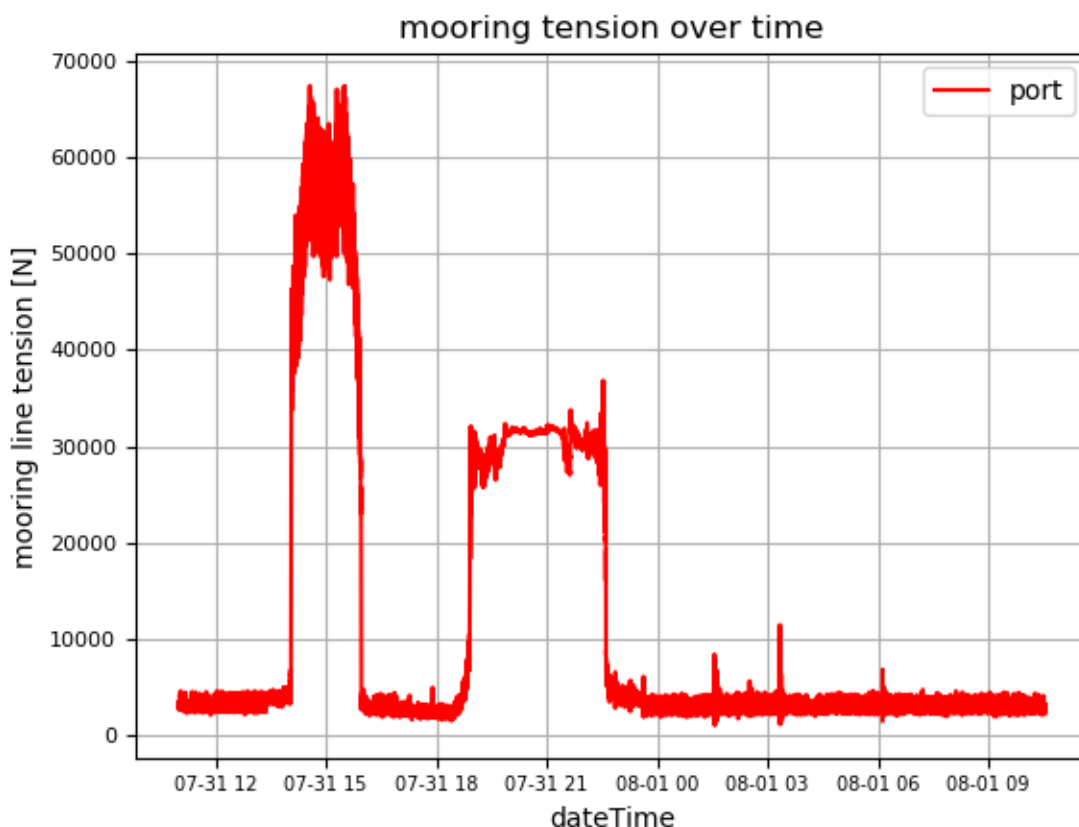
Throughout the deployment and retrieval tests device pitch and roll data along with mooring line load cell data was collected. Although one of the mooring line load cells lost its functionality, the measured loads aligned well with predicted loads.

Figure 31: Mooring line tension during deployment tests. First peak represents the attempted bow-down deployment. The second peak represents the side pivot launch deployment. Predicted deployment loads at Igiugig for a *single* mooring line were 62kN, compared to the 67kN measured in the end pivot launch configuration. Based on numerical modeling conducted using OrcaFlex and Proteus modeling tools, it is expected that mooring line loads during a side pivot launch would be approximately half of those during an end pivot launch. Note that predicted loads do not include load factors and are far less than the mooring line design loads of 325kN

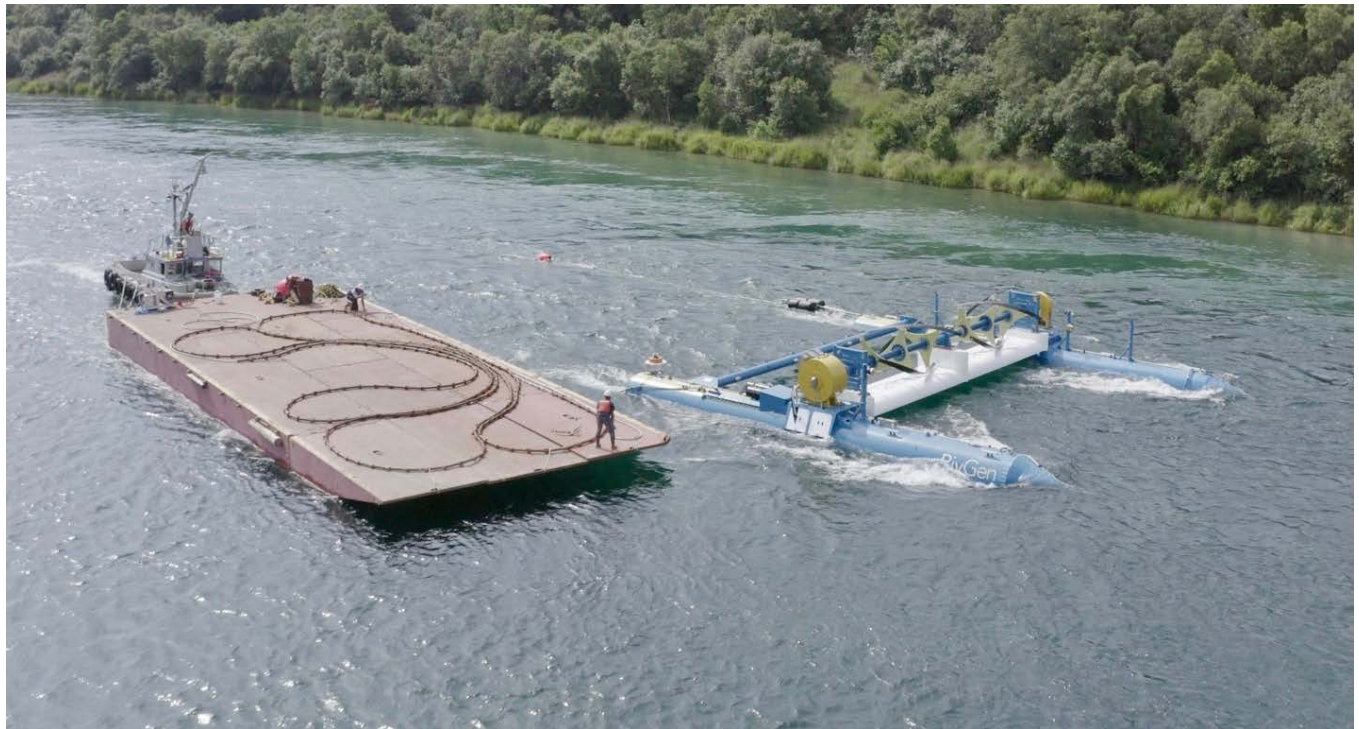
Cable installation began on July 23 by bringing the barge with the staged cable down the river to the device (Figures 32 and 33). Once the barge pulled up next to the device the cable grips on the device end of the cable were attached to the device on the surface and the connectors were temporarily secured. Once the cable was attached and all deck personnel were in safe locations, the barge began to move across the river channel towards the junction box. As the cable was pulled overboard the tag lines were cut trying to keep an even layout of the cable on the riverbed. About 20ft from shore and about 100ft from the junction box the barge ran aground, and the operation paused.

Figure 32. P&D cable installation

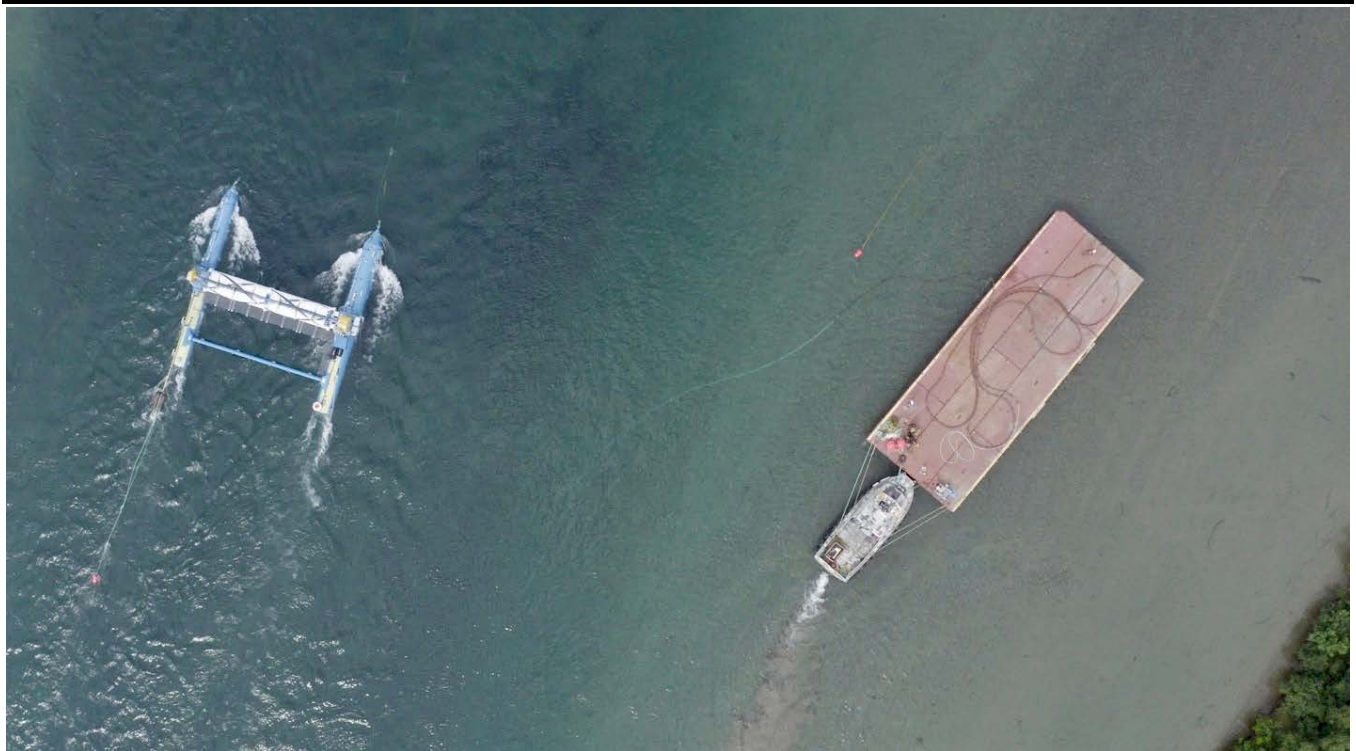
Figure 33. P&D cable installation, moving the barge towards the come-ashore

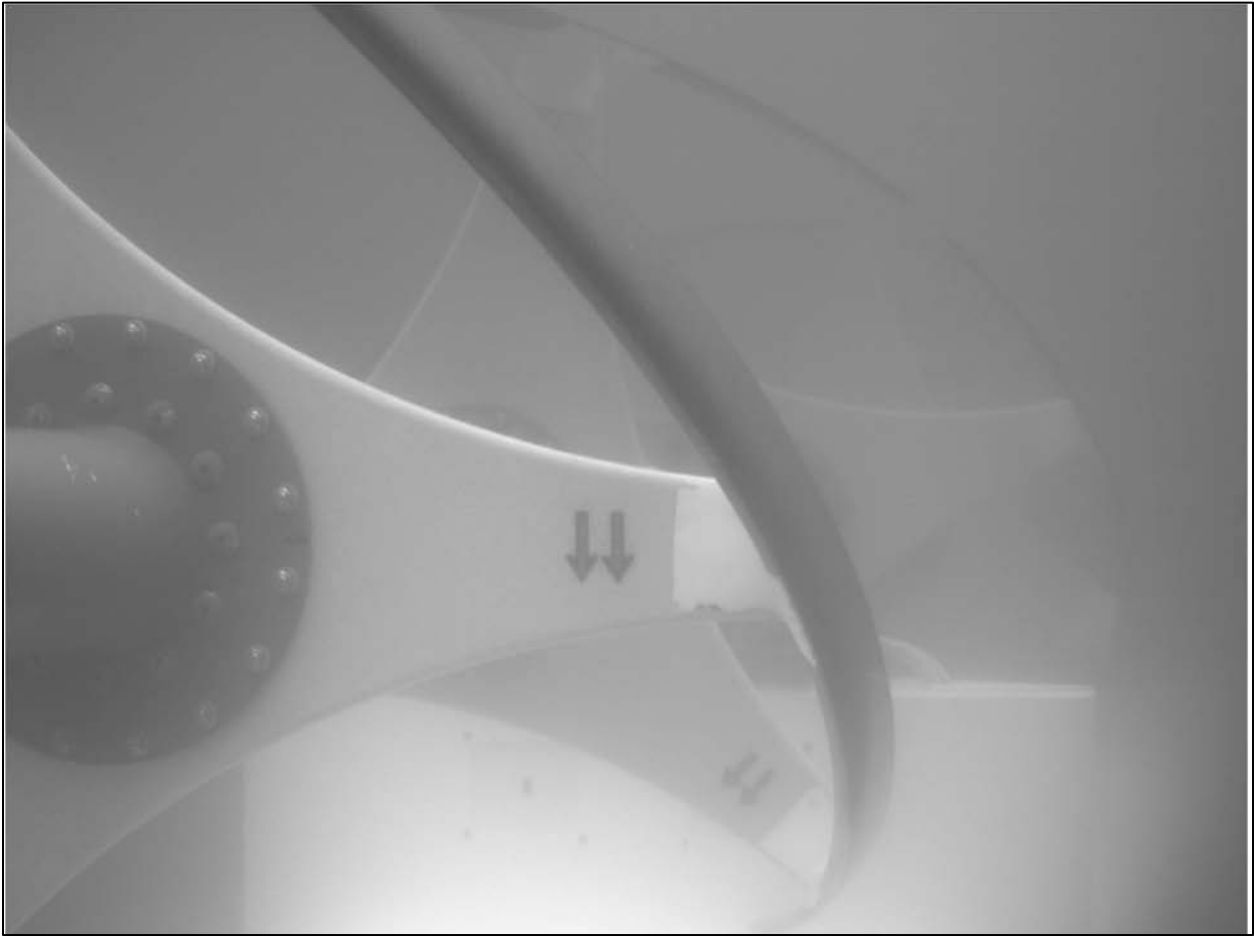
The environmental monitoring system was tested as part of the initial validation tests with a biologist from the University of Alaska Fairbanks (UAF) onsite to review images from the cameras. This review confirmed that the quality, resolution, and orientation was acceptable for the monitoring effort (Figure 35). This was further validated during subsequent tests which included lowering fishing lures into the camera’s field of view to confirm that objects the size of salmon smolt could be adequately detected.

Figure 35. RivGen turbines as viewed from the downstream environmental monitoring cameras

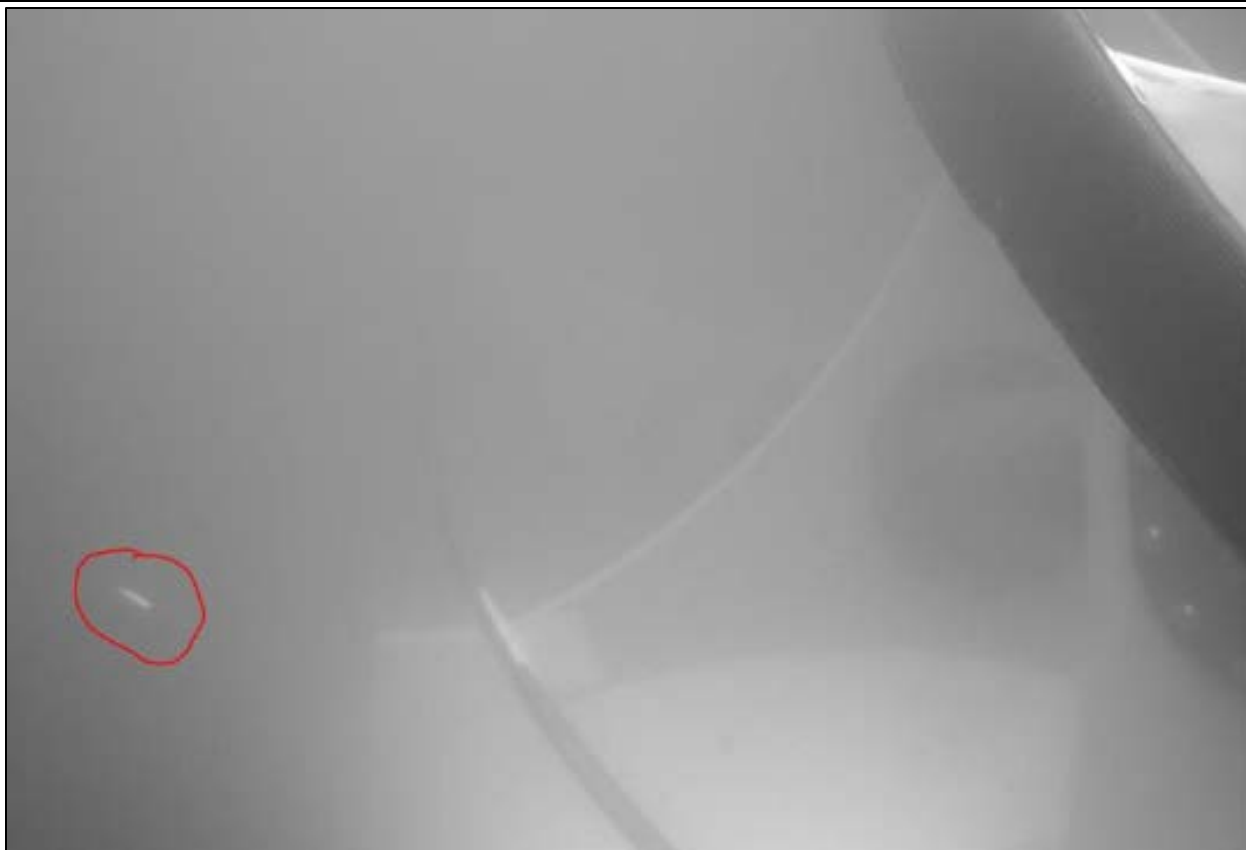
Figure 36. Environmental monitoring validation tests. A fishing lure (circled in red) is the approximate size of a salmon smolt.

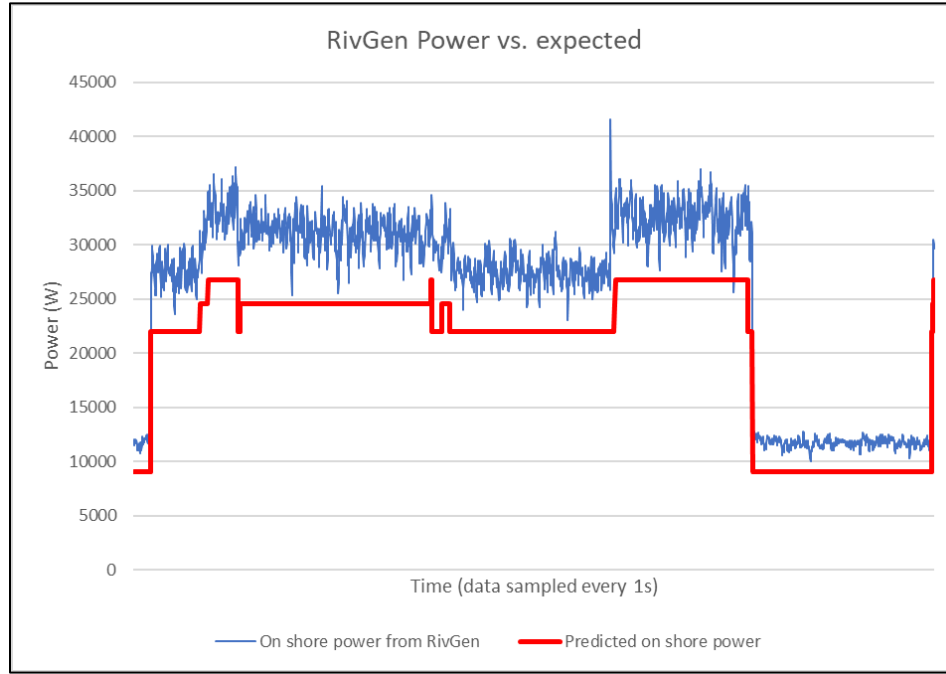
discrete set points (Figure 37 and Figure 38) the complete power vs. tip speed ratio (TSR) was determined based on these secondary load points (Figure 38).

Figure 37. Actual vs. predicted power from the RivGen Power System during secondary load performance tests

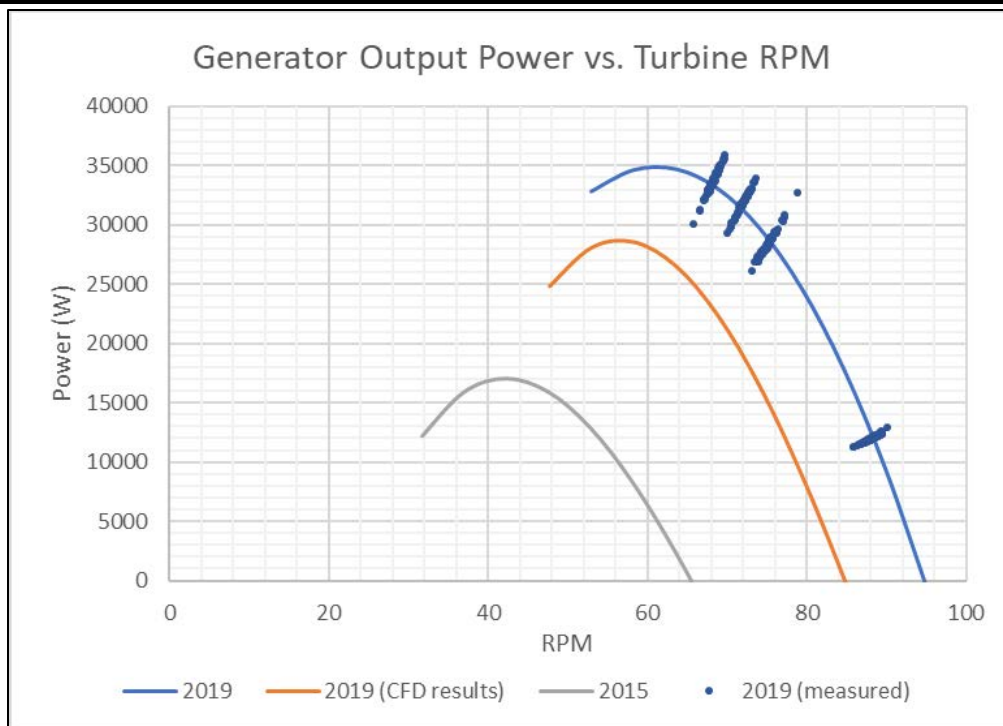
Figure 38. Preliminary power output of the RivGen 2.0 compared to the RivGen 1.F and predicted power for a common (2.1m/s) water speed
